LORAIN COUNTY • ROOF EVALUATION 2011 REPORT

COUNTY COURTHOUSE
308 Second Street
Elyria, Ohio

■ 2011 ROOF INSPECTION (By **RMCS** – 8/8/2011)

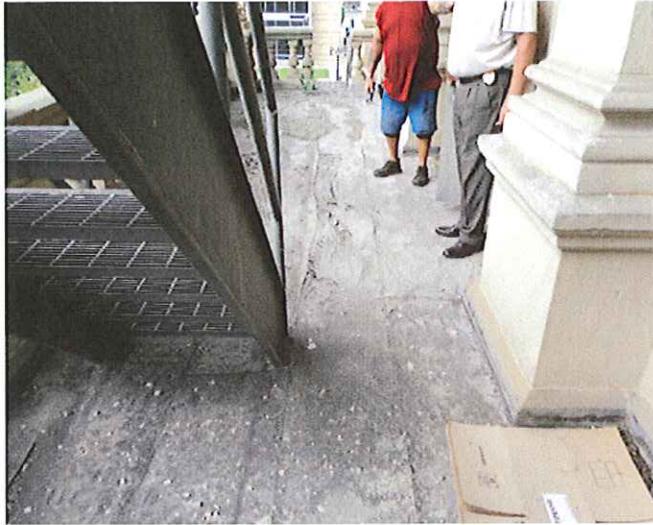
1-C Roof "C": View of porch roof that is in total failure and needs to be replaced. Note the tree growing not a good sign.

10. There is a porch roof located on the south side of the building that is in total failure and needs to be replaced. Due to the surrounding stone work and drainage careful consideration must be given as to the final replacement.

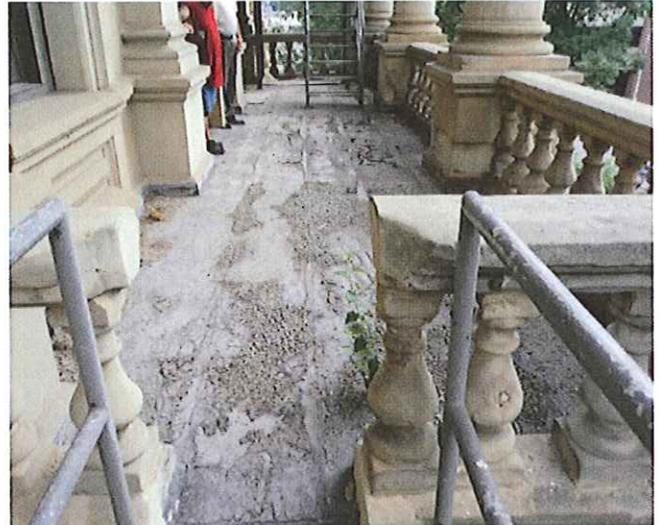
2-C View from opposite side. They have been using bentonite to try and stop the leak. Waste of time and money and makes things worse.

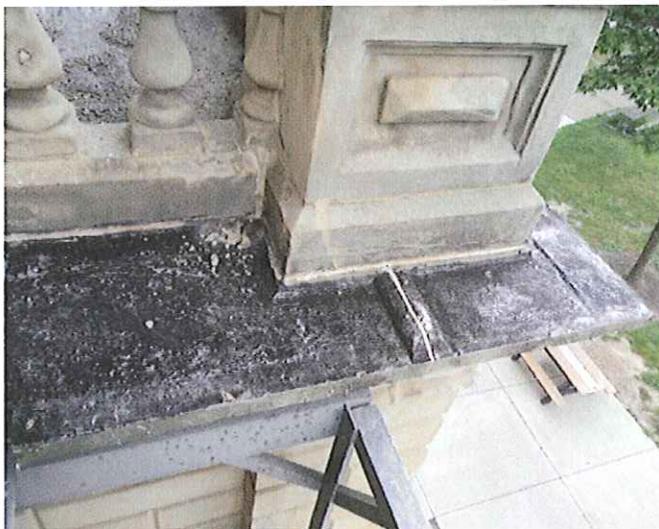
3-C Typical detail of outside the stone balustrade which will require some time to review and detail.

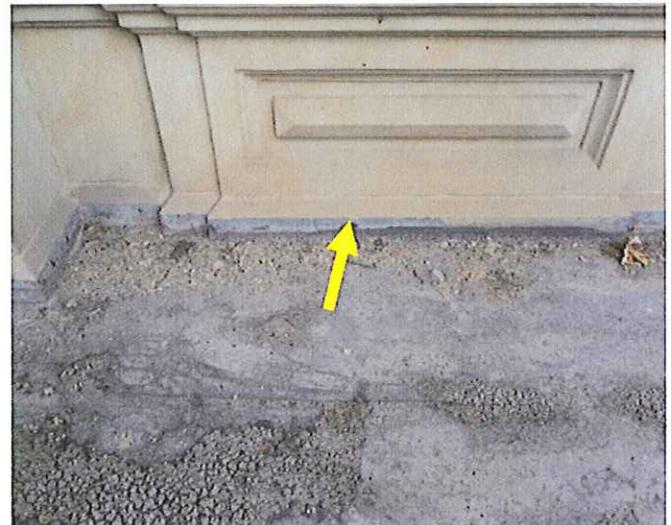
4-C View of the interior side of the roof which creates a flashing nightmare.

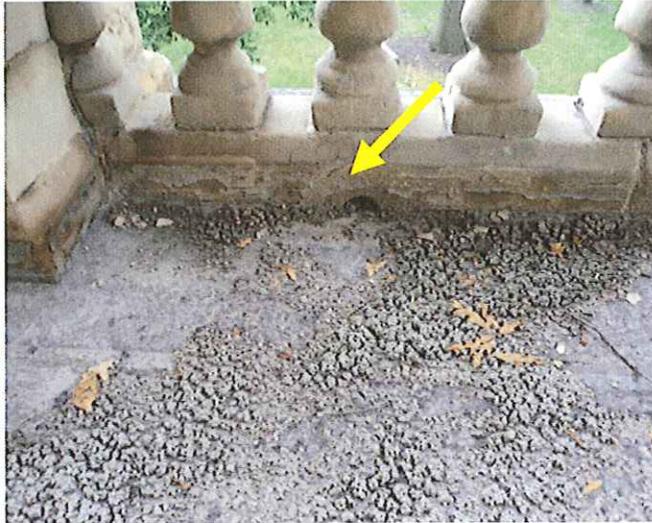
5-C There are several opening that extend under the sandstone which again creates a flashing nightmare.

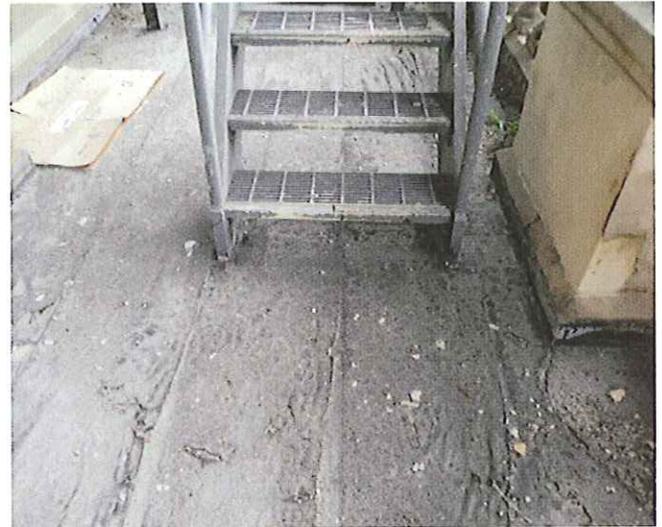
6-C These stairs need to be set on a pate rail to properly seal to the new roof.

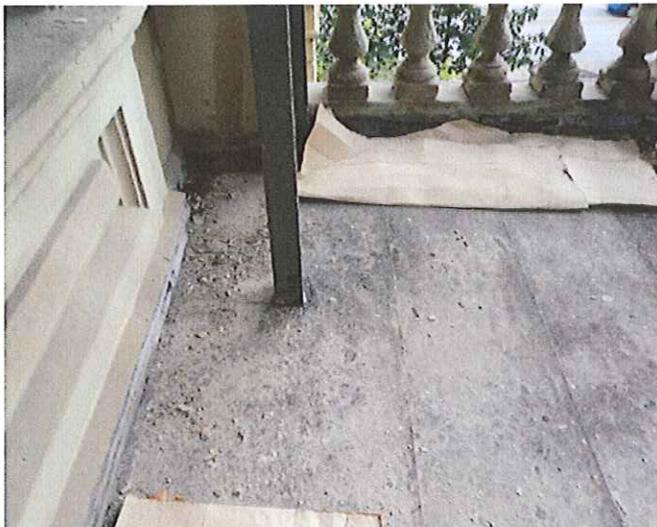
7-C These supports need to be set off the roof to allow for proper flashing.

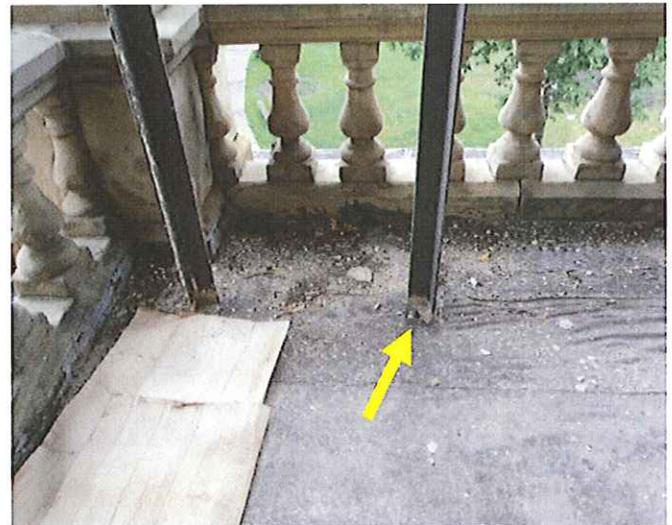
8-C This steel needs to be off the roof so they are properly flashed.

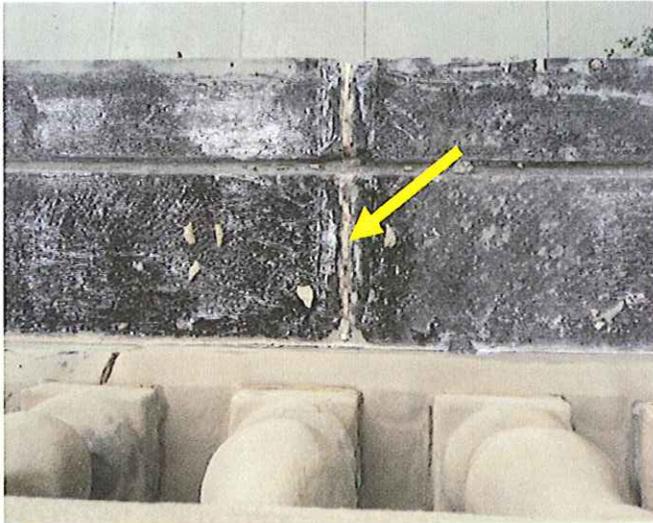
9-C One of several caulked joints that should be looked at and caulked as needed.

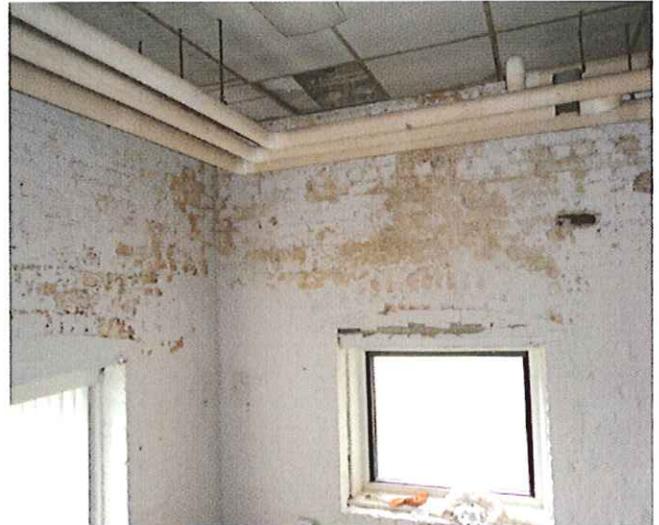
10-C This is the leak that is showing up under the porch roof.

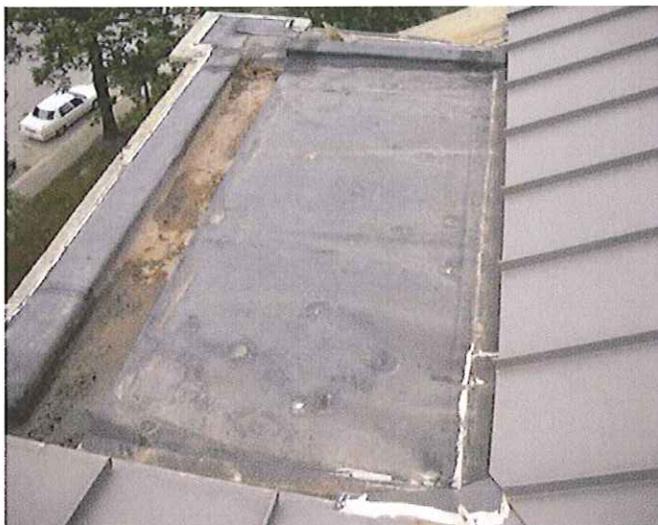
11-A Top Roof (SE) - View of the rubber roof at the south east corner. This particular one has an active leak.

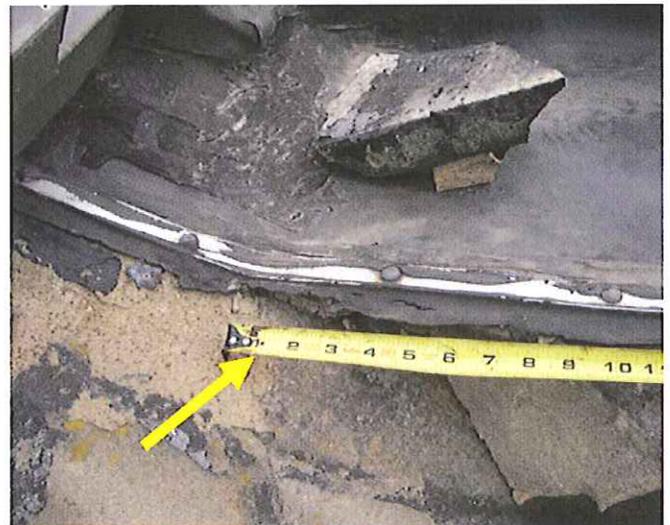
8. Much of the stone work has various openings that should be addressed. There are some areas where vegetation has taken root and these must be removed to prevent further damage to the structure. There is one area section 1 where a large piece of the stone has broken away and could be the source of the reported leak.

12-A Top Roof - There is a large piece of stone missing which should be reset and sealed which may be the source of the leak

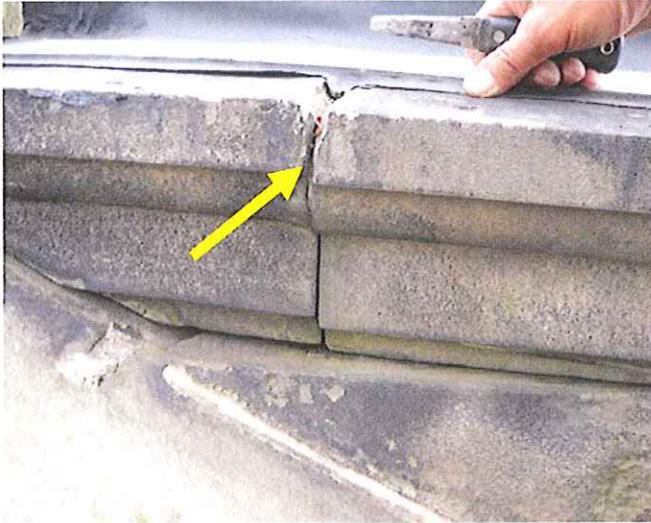
13-A Top Roof - Large opening at the joint in the sandstone.

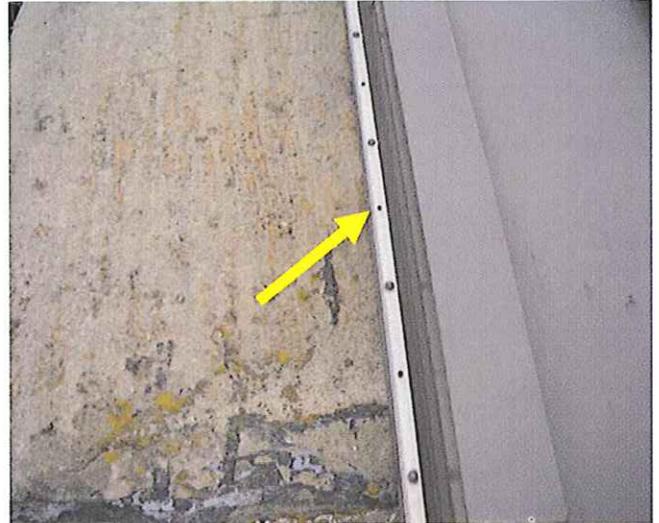
6. The box gutters need to be cleaned of all dirt and debris to facilitate drainage.
7. Where the metal roof joins the stone perimeter edge it was secured with termination bar and fasteners but we did not see any signs of sealant at this point

14-A Top-Roof - Where the metal roof is sealed to the sandstone there is no obvious sealant. I think it is needed.

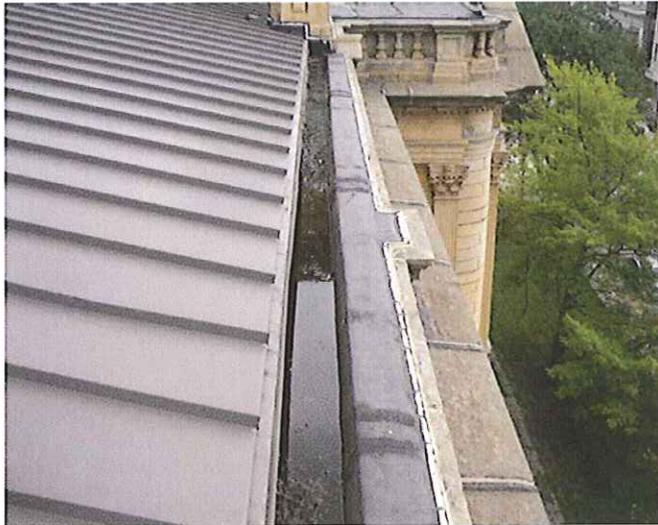
15-A Top Roof - One of the box gutters that is located around the perimeter and drains the metal

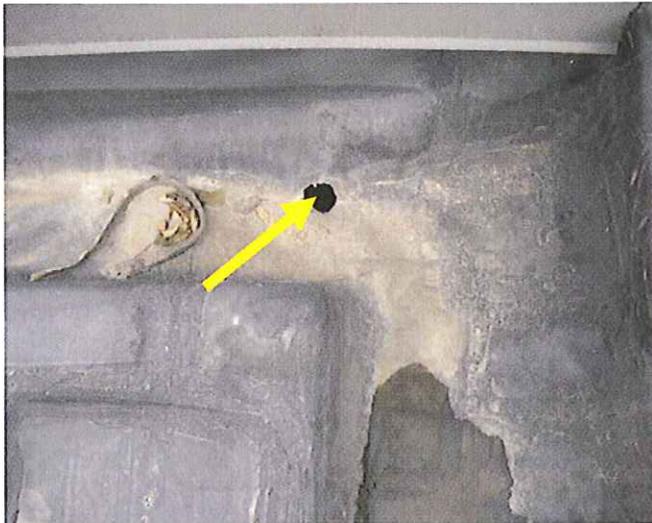
4. The flashing detail at the box gutters does not have a proper seal at any of the roof drains. They just cut a hole in the rubber which is too small for proper drainage and is most likely letting water in due to no seal being present.

17-A Top Roof - None of the roof drains were properly sealed. They cut a hole which is too small and this needs to be properly sealed. Not sure what the underside condition is.

- **Recommendations;** Install proper seal at roof drains in box gutters and increase the opening size to allow for adequate drainage. These may require drain inserts.
- Inspect flat sections as well as box gutters and make repairs as necessary. Pay particular attention to any active leaks such as section 1.
- Clean all debris from box gutters.
- Install sealant where metal roof ties into stone coping.
- Remove all vegetation including stone areas that can be reached in a safe manner.
- Repair large hole in saddle
- Install a urethane sealant at termination bar on the exterior side of box gutters as needed.
- Install rubber tape to concealed splice plates at hip ridges or any other backwater laps that are discovered.
- Caulk window frame

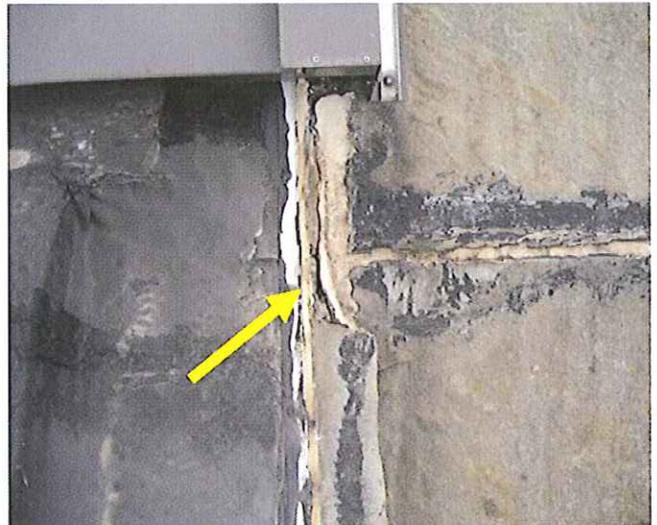
18-A Top Roof - This is at the transition where the steep roof meets the flat roof with open sealant.

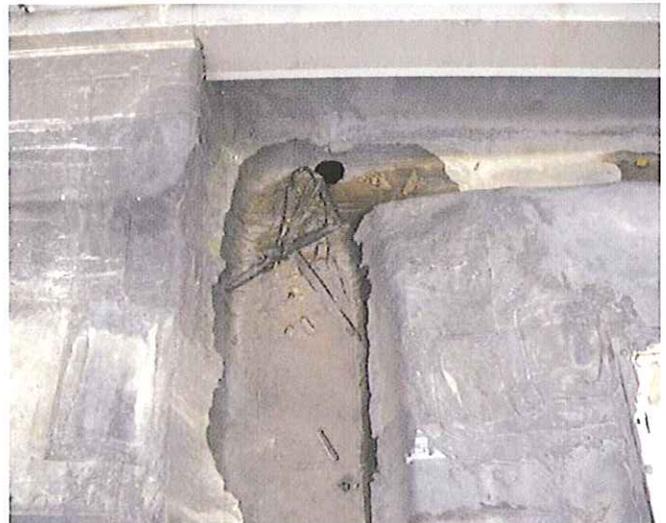
20-A Top Roof - Again the drain was not properly sealed and the hole is too small to let enough water drain during heavy rains.

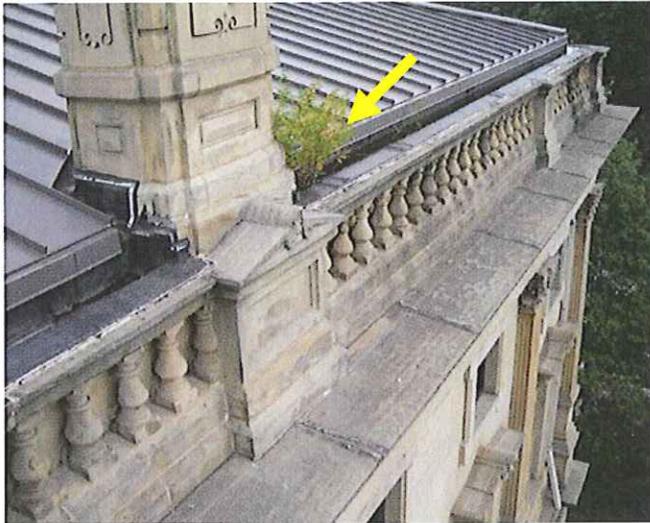
21-A Top Roof - View of the typical box gutter around the perimeter of the metal roof. This tree can cause serious damage if not removed.

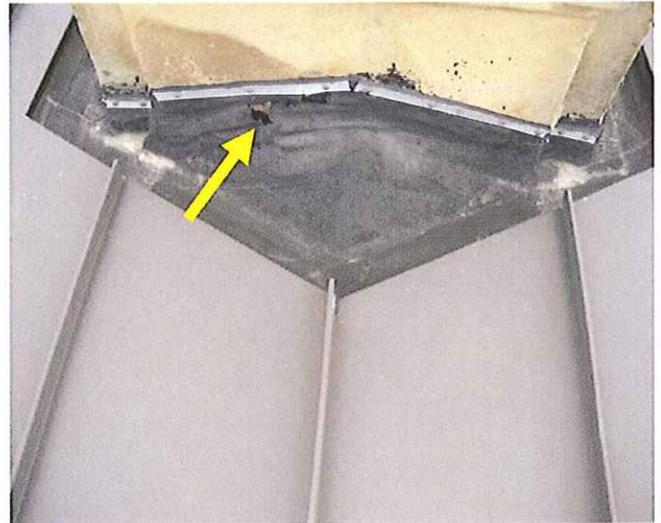
24-A Top Roof - This cricket has a major tear and must be repaired immediately if not sooner.

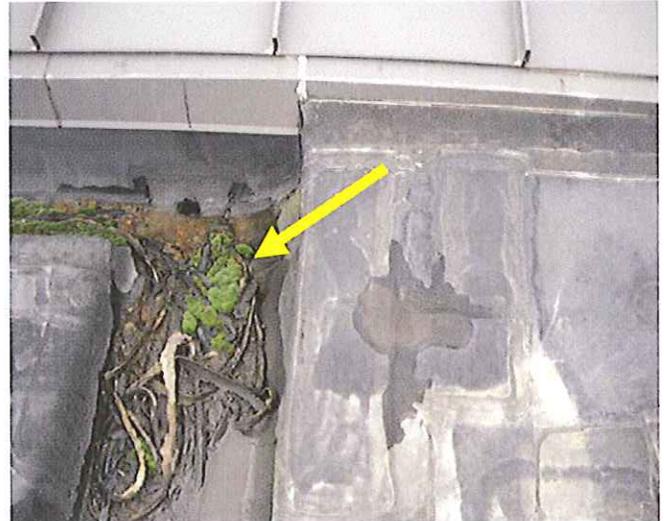
26-A Top Roof - There is numerous areas of debris that needs to be cleaned out so it does not block the roof drains.

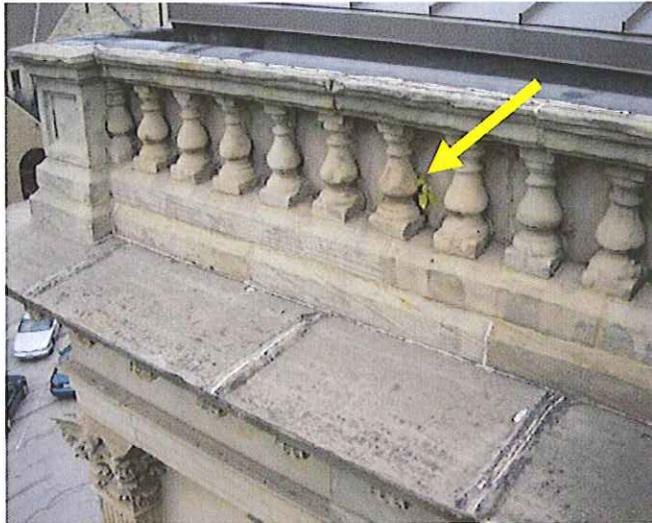
29-A Top Roof - View of the stone work on the outside of the building showing the balustrade and the ledge. Note the vegetation.

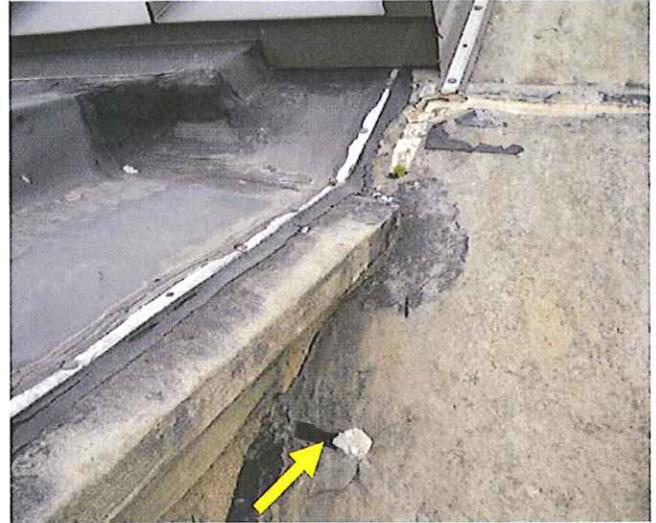
30-A Top Roof - While this is probably not leaking there are several issues here that should be sealed.

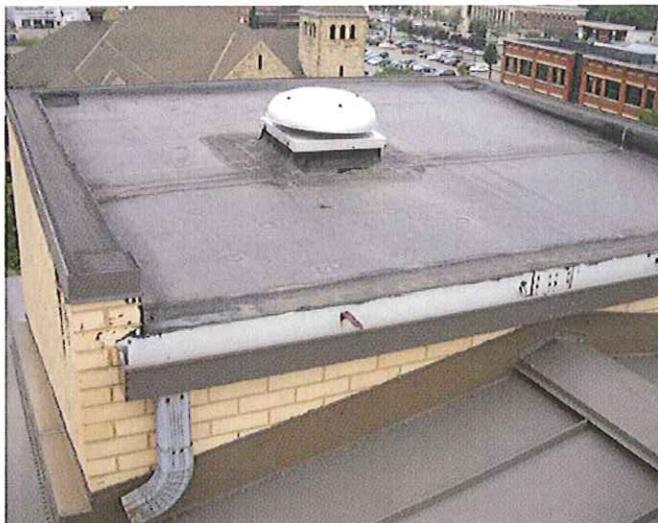
31-B Top Roof - View of the flat roof which appears to be in fair condition.

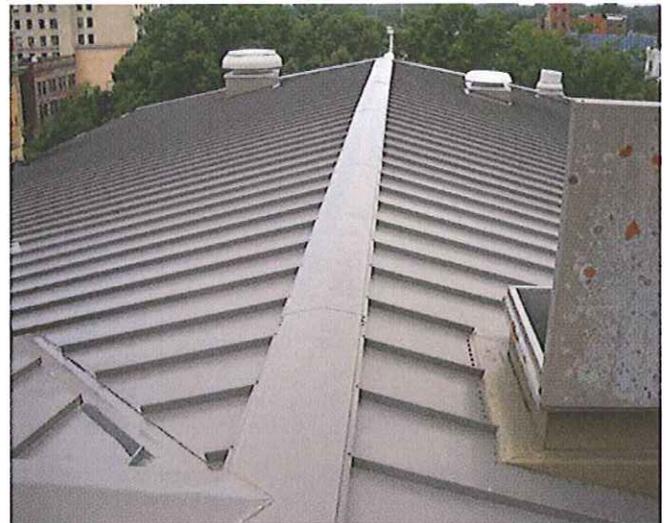
32-A Top Roof - View of the metal roof looking north. This roof appears to be in good condition.

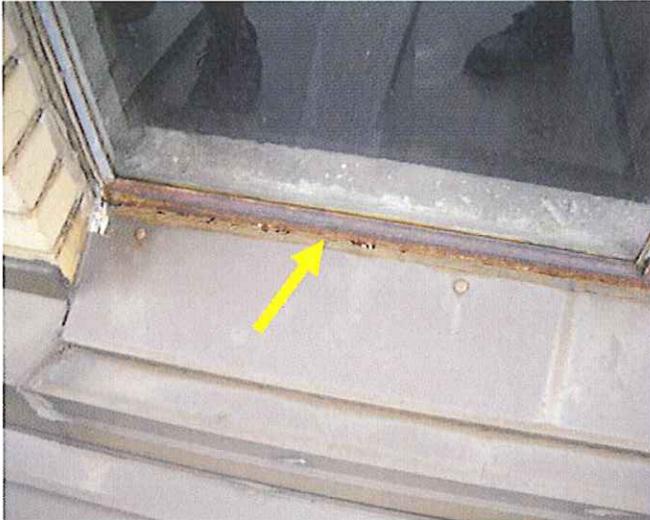
33-A Top Roof - The window sill which is under the flat roof needs to be sealed with sealant.

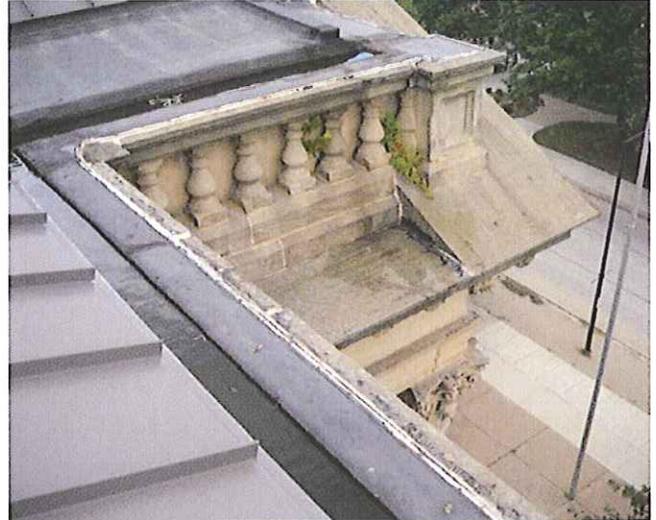
34-A Top Roof - This gutter was full of water due to a blocked drain. We were able to find the drain and unblock but there is so much gunk in there that it may block up again.

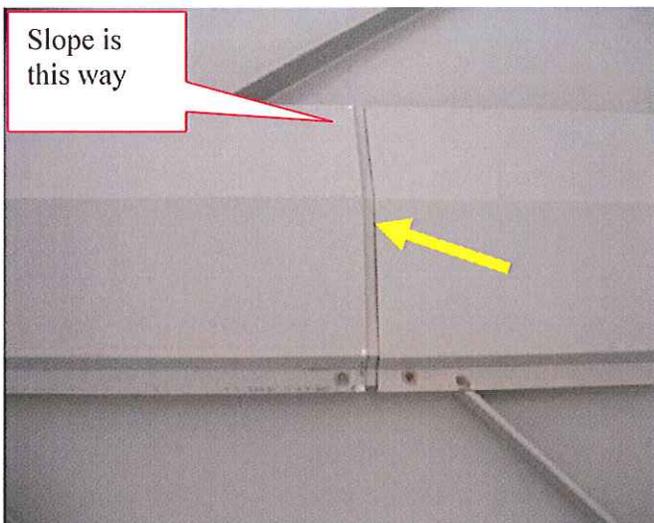
9. The metal roof is a hip design and at the hip ridges the cap metal was installed with concealed cover plates. This creates a backwater condition that allows water entry under the metal roof. The metal should have been lapped with the upper sections overlapping so there were no back water laps. This should be addressed after discussions regarding the desired life expectancy.

35-A Top Roof - They used a concealed cover plate (Creating Back Water Condition). The downward seam is a direct path for water to get in under the metal roof.
