LORAIN COUNTY • ROOF EVALUATION 2011 REPORT

RECORD CENTER & EMERGENCY SERVICES BUILDING

320 N. Gateway Blvd.  
Elyria, Ohio

■ 2011 ROOF INSPECTION (By *RMCS* - 6/29/2011)

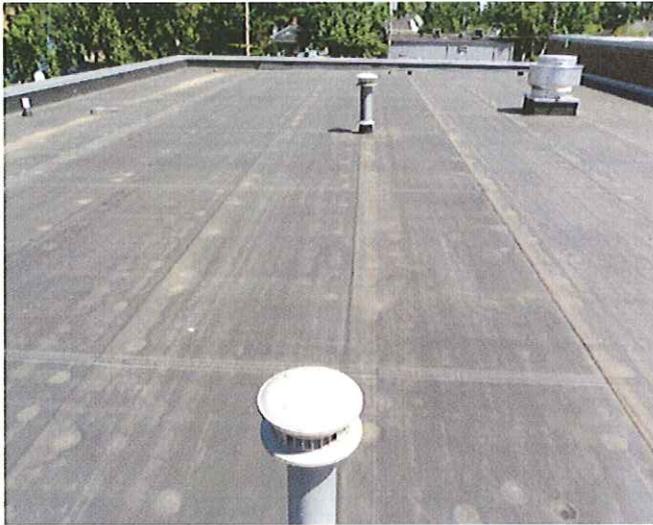
1. **Section A:** totally adhered membrane in very good condition no work required.
2. **Section B:** totally adhered membrane in very good condition no work required.

**1-A** Overview of this section of roof. We started at the west side and worked our way across.

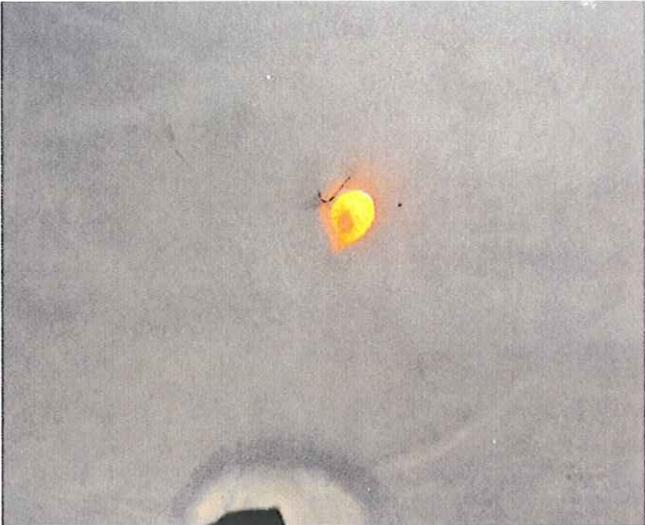
**2-A** Found a puncture in roof which we repaired. This is a newer roof and in good condition.

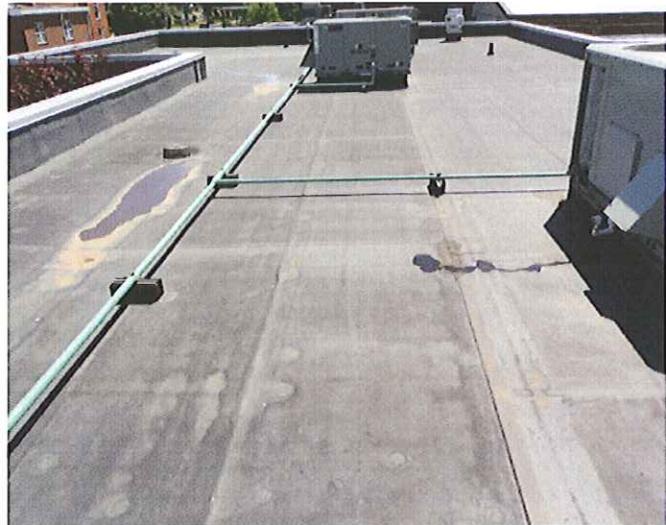
**3-B** Overview of this section of the roof. This is a newer roof and in good condition.

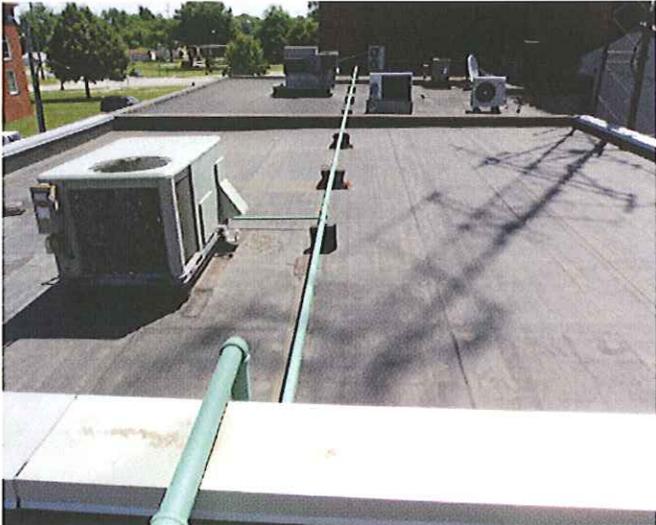
3. **Section C:** totally adhered membrane in very good condition no work required.
4. **Section D:** totally adhered membrane in very good condition no work required.

**4-C** Overview of this section of the roof. The arrow is pointing to an older roof and is not part of this phase

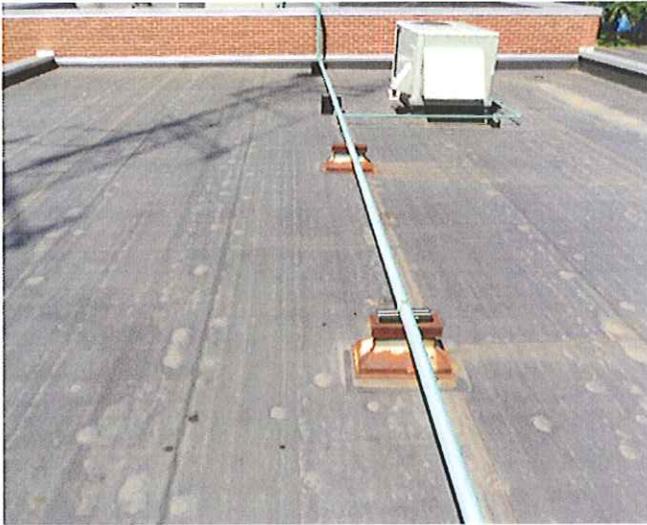
**5-C** Overview of this section of the roof which is a newer roof and in good condition.

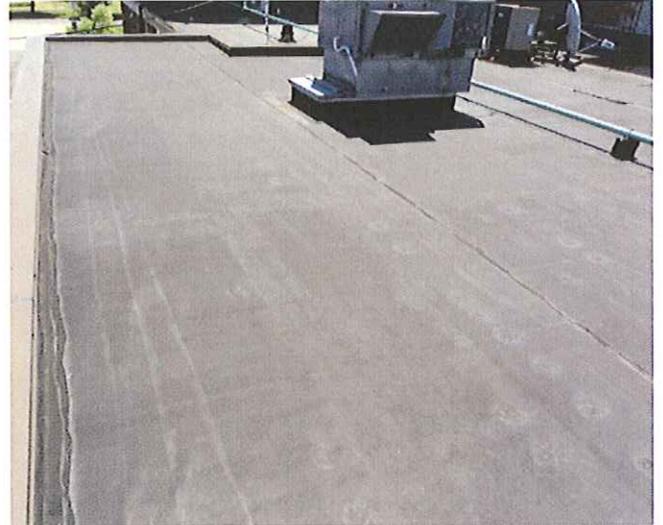
5. **Section E:** totally adhered membrane in fair condition with some minor repairs required.
  - a. The gutter is beginning to show signs of rust and should be cleaned and painted.

**6-E** This is an older roof which is in fair condition.

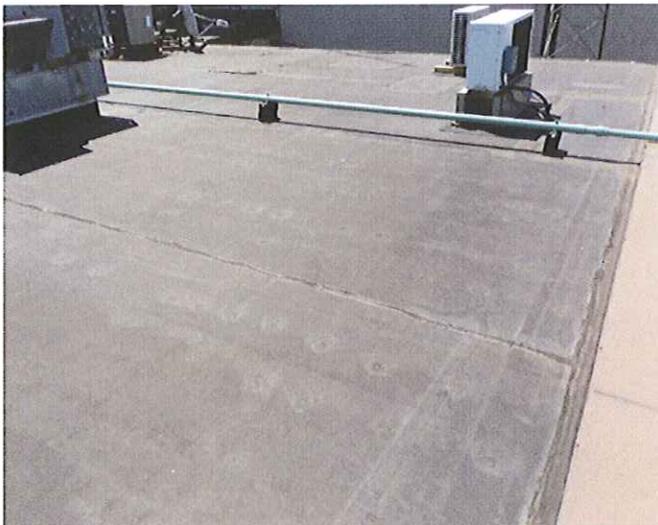
**7-E** This is an older roof which is in fair condition.

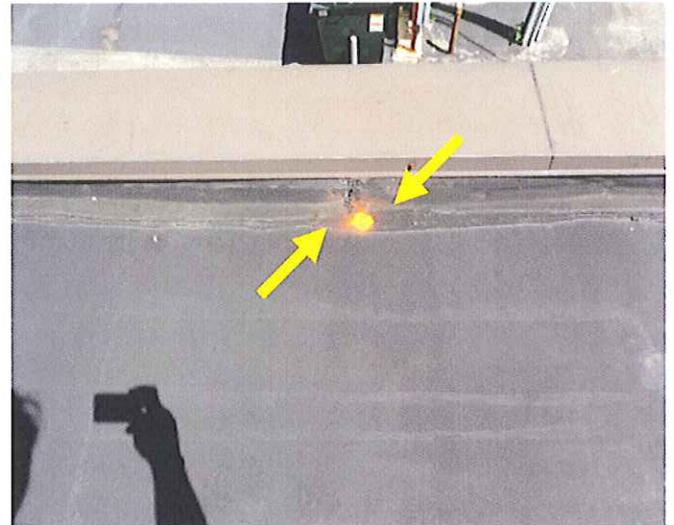
**8-E** Found an opening at the base tie in.

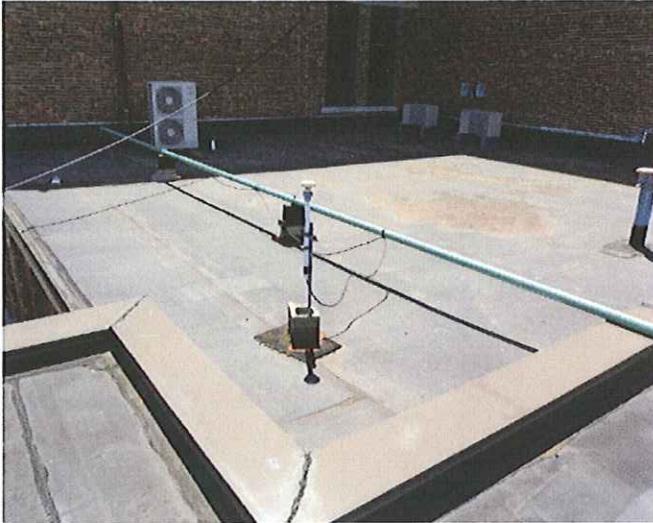
6. **Section F;** Totally adhered membrane in poor condition. Found puncture and there is a lot of wet insulation. There are two roofs in place.
7. **Section G;** this is a sloped roof that has a cap ply of a modified membrane installed over at least three other roofs with no insulation within the system.

**9-F** This is the last section of rubber. There is wet insulation and we found a puncture in the roof which we repaired.

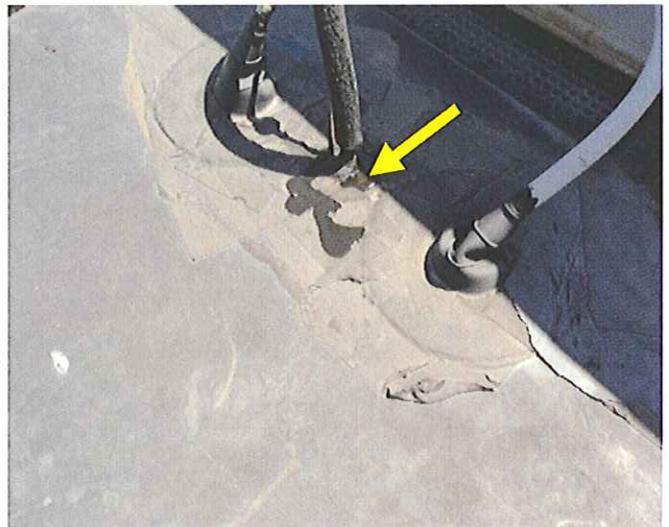
**12-F** Improperly installed lines which are most likely a source of leaks.

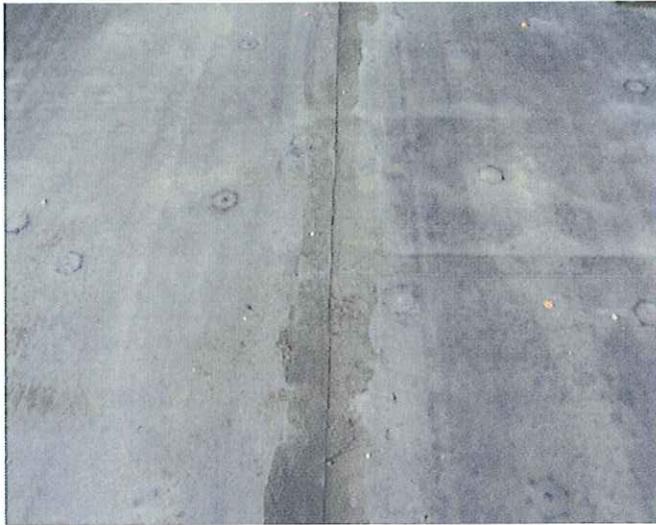
**13-F** Someone attempted to repair a seam using what appears to be a trowel grade of asphaltic

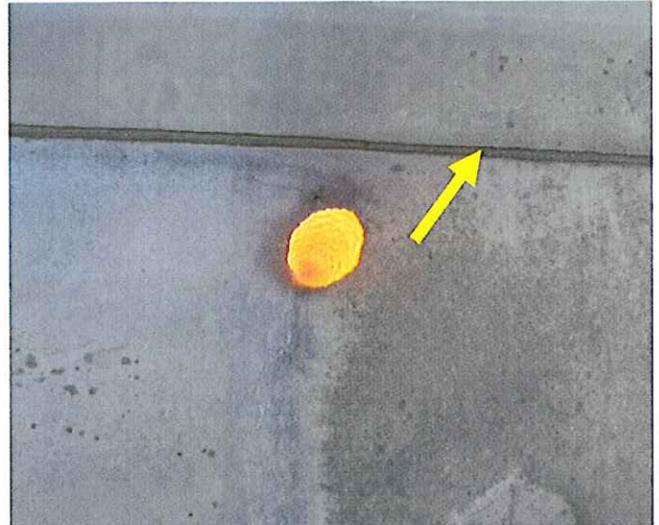
**14-F** Found a puncture and this was repaired

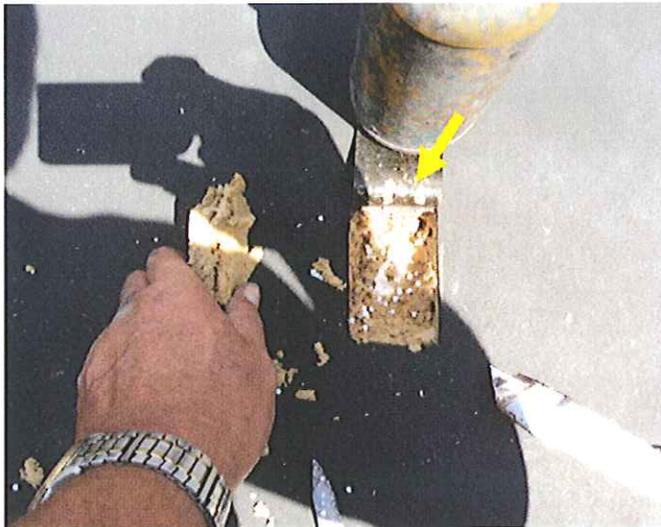
**15-F** Test cut showing two inch Isocyanurate insulation that is 100% saturated over an existing built up roof

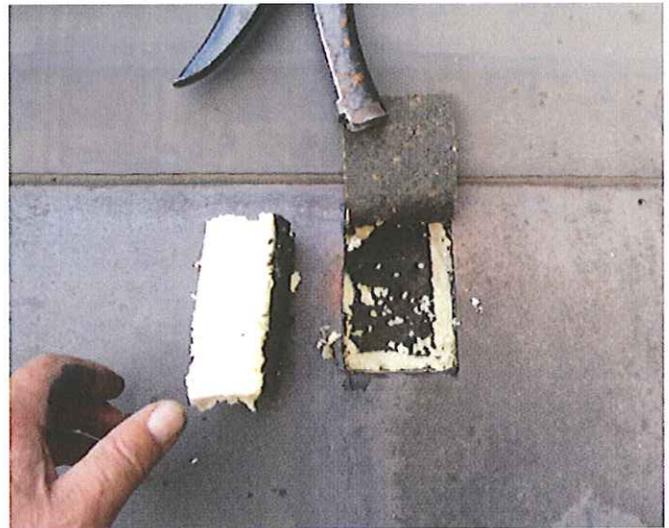
**16-F** I could not test cut the lower roof due to the amount of moisture between the two roofs.

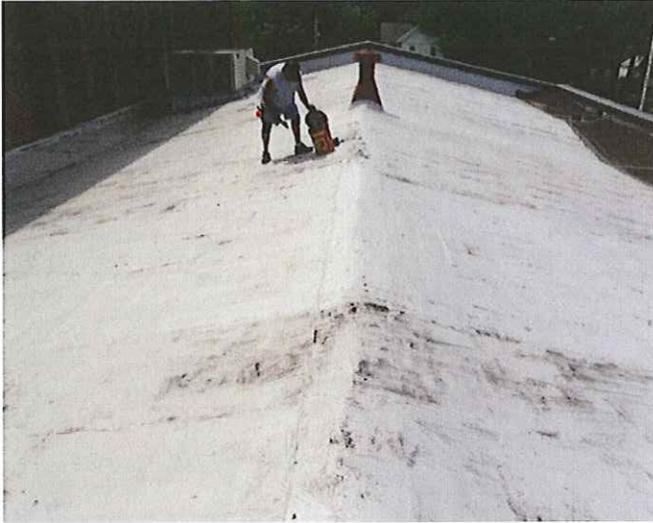
**17-G** This roof is a modified membrane with an aluminum coating.

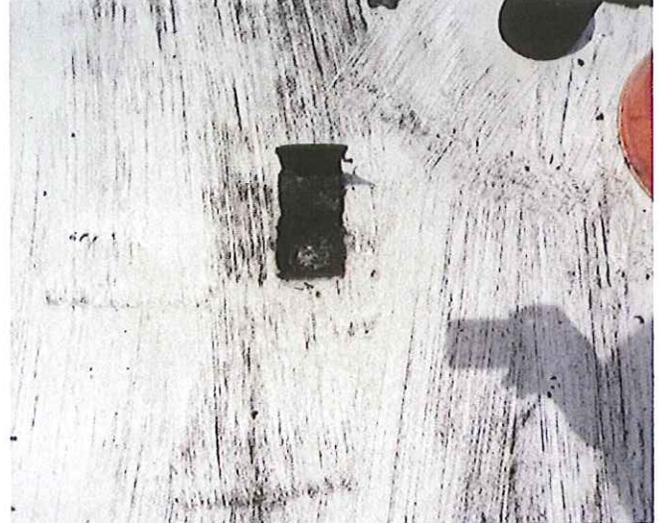
**18-G** The test cut shows a concrete deck with 2 – 3 conventional BUR roofs and then a base sheet and modified was torched to the roof.

- a. There is a saddle located on the west side which is in total failure.
  - b. This roof should be removed down to the deck and a new roof installed.

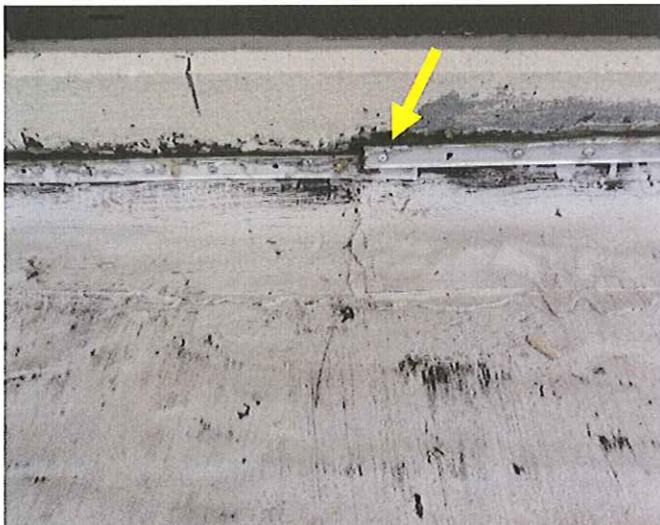
**19-G** Improper flashing details and most likely is allowing water in the system.

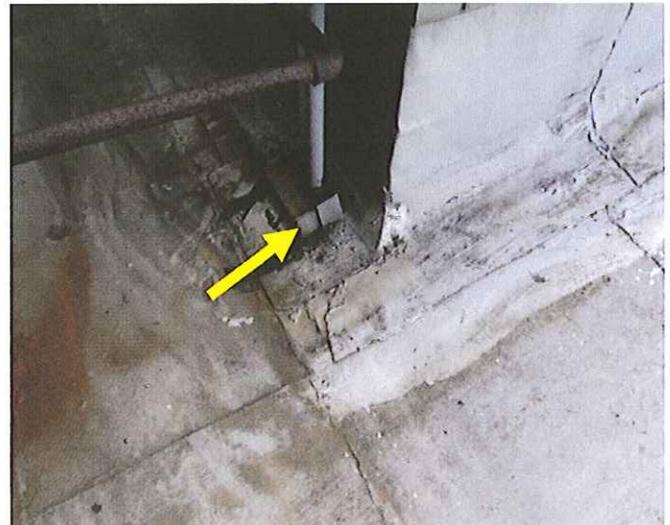
**20-G** Pitch pocket that is open

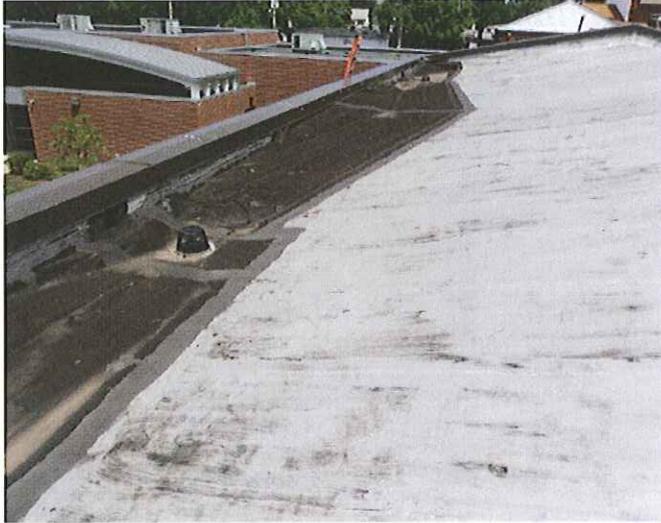
**21-G** Someone attempted to install some tapered insulation and a repair using a modified membrane. This is a very poor installation and is in total failure and should be replaced.

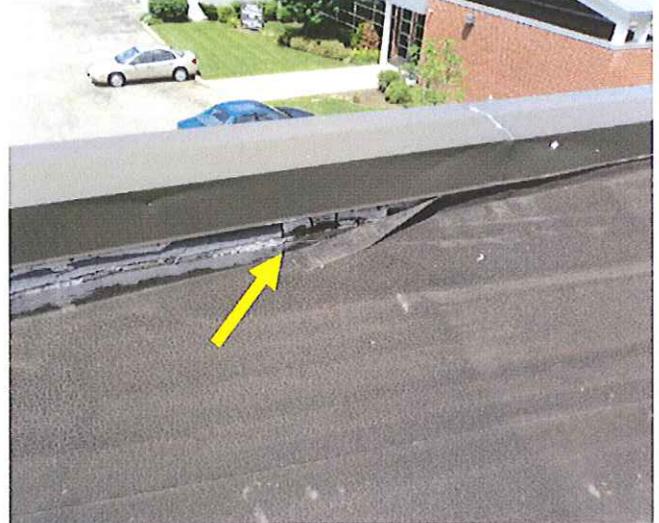
**22-G** The flashing has fallen down allowing substantial water between the roofs.

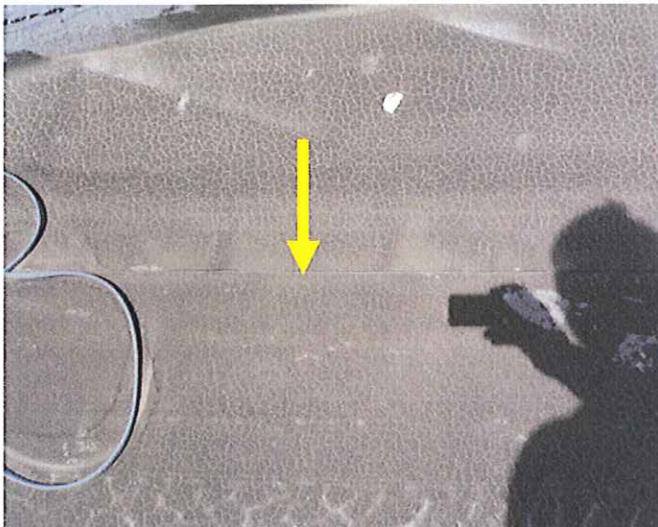
**23-G** There is no flow at the laps which is problematic

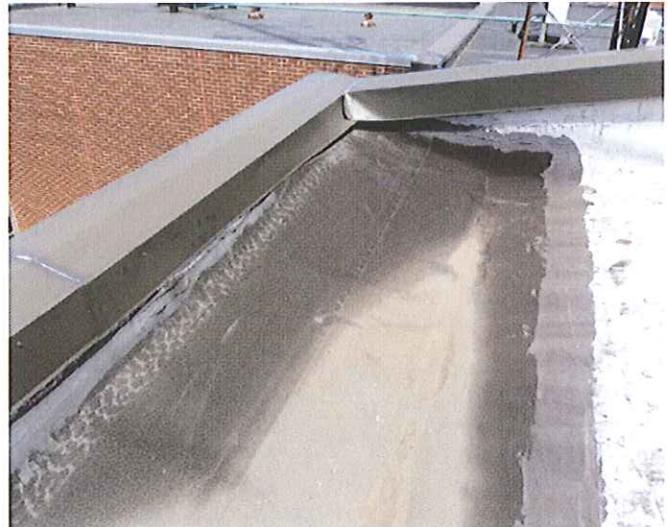
**24-G** No Flashing was installed and the top of the ply is open and allowing water in.

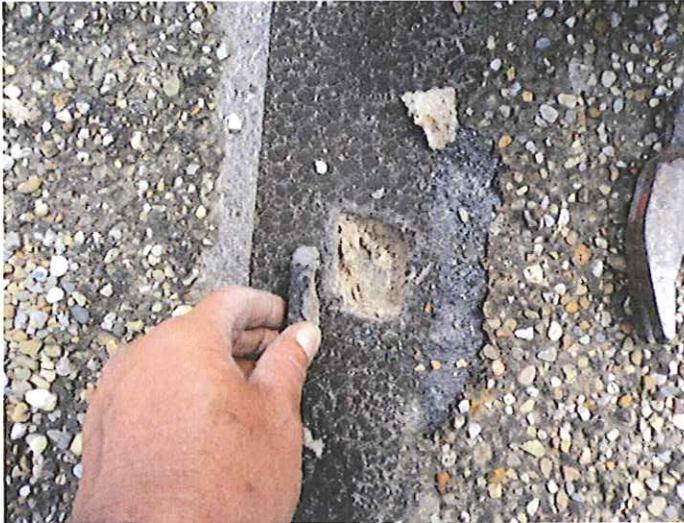
8. **Section H;** this roof is a conventional BUR roof with a 4-ply roof installed over 1" perlite insulation.
  - a. The deck is a concrete deck.
  - b. The flashing needs some minor repairs and will need continuous maintenance.

**25-H** Upper school roof test cut showing concrete deck, 1" perlite insulation and a 4-ply asphalt & gravel

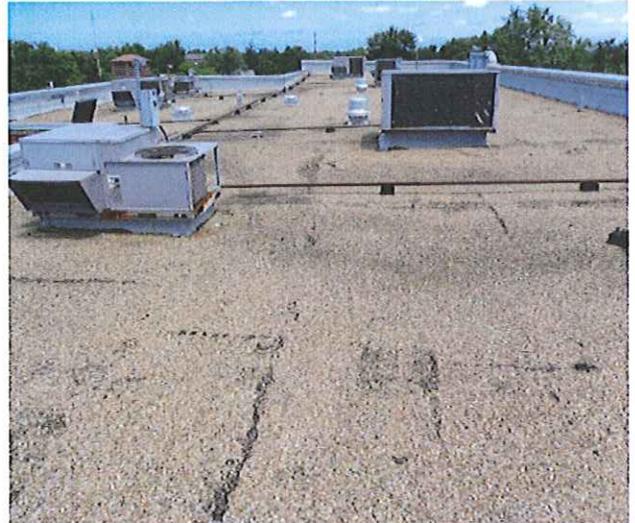
**26-H** Overview of the roof. There is some evidence of the top pouring sliding due to the slope and improper use of type of asphalt

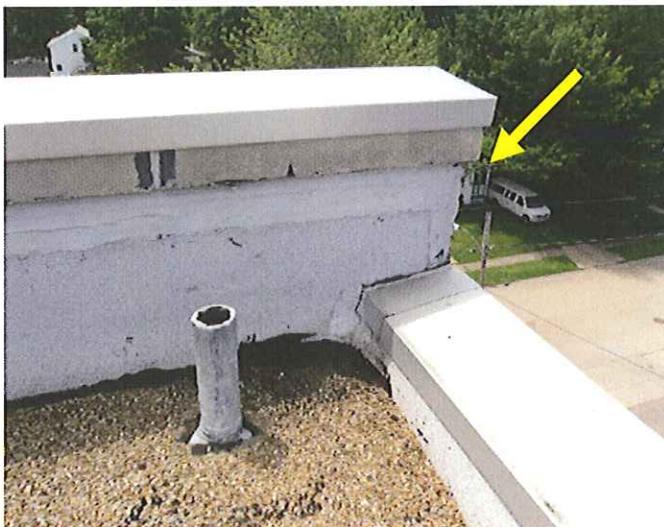
**27-H** Showing the different details

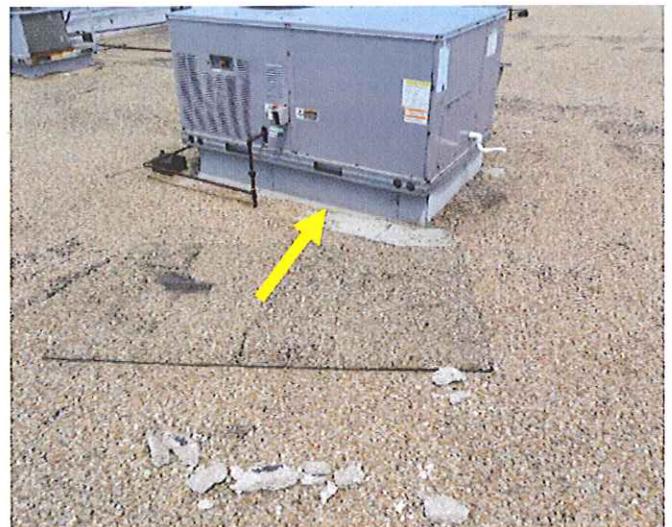
**28-H** Aftermarket installation that did not use a cant strip at the angle change.

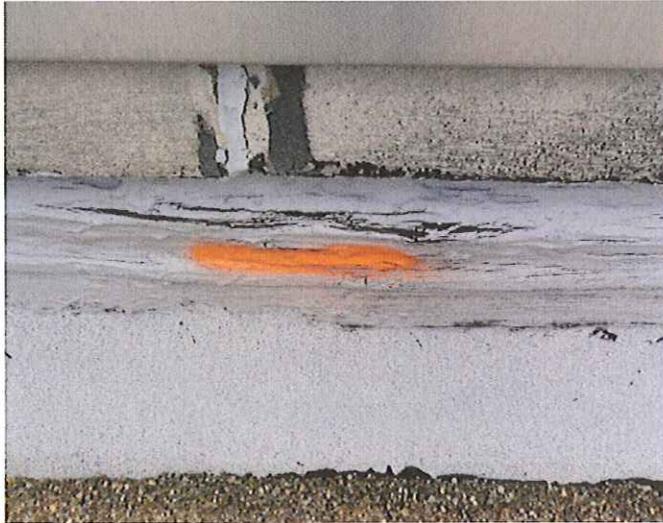
**29-H** The top of the flashing does not have a metal counter flashing and is open.

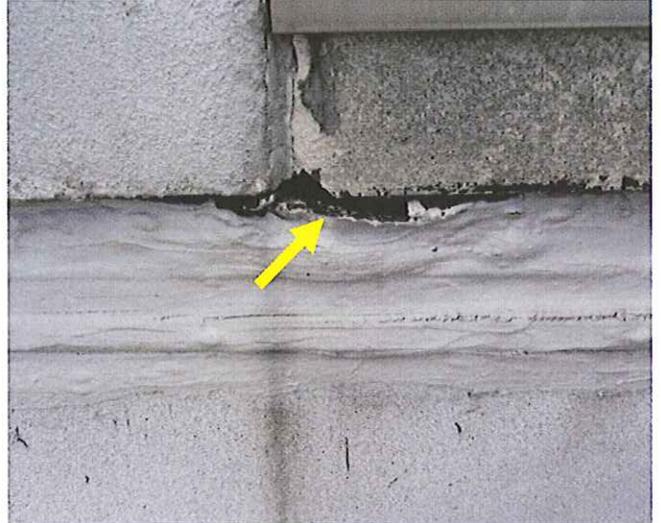
**30-H** Large opening at the top of flashing which is allowing water to get in and because of the concrete deck is ruining your insulation but not showing up as a leak

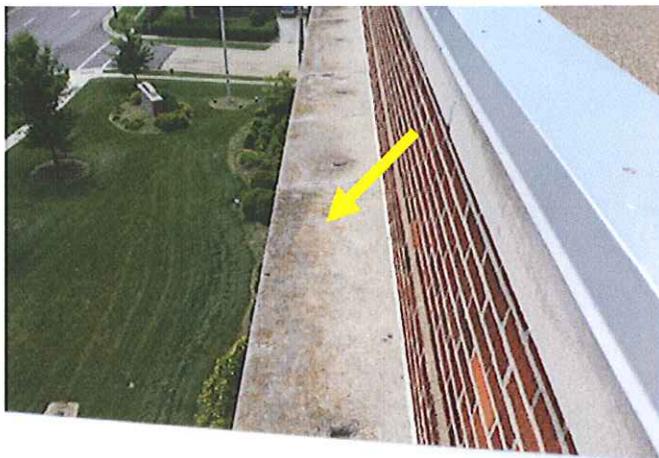
**31-H** Concrete ledge that appears to be in good condition.

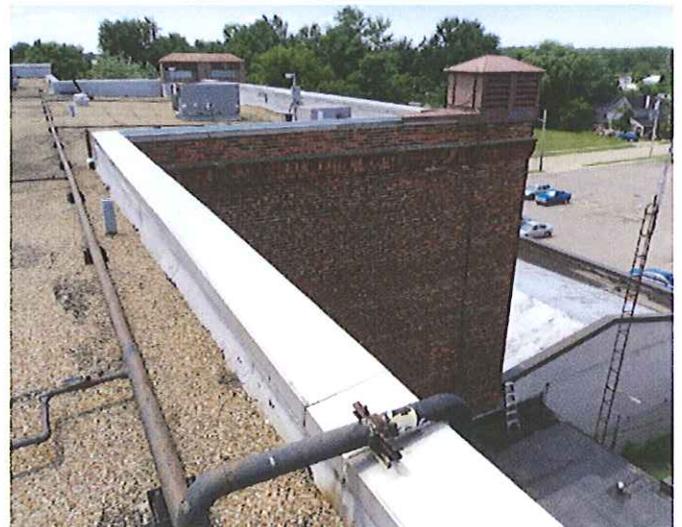
**32-H** Overview of the roof

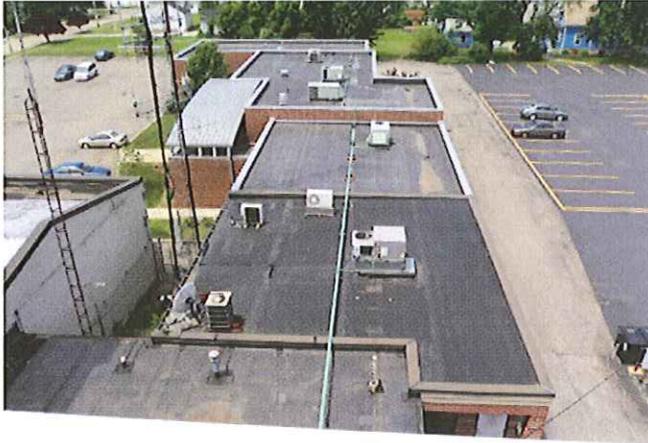
**33-H** Overview of the lower roofs. We started our inspection at the far end

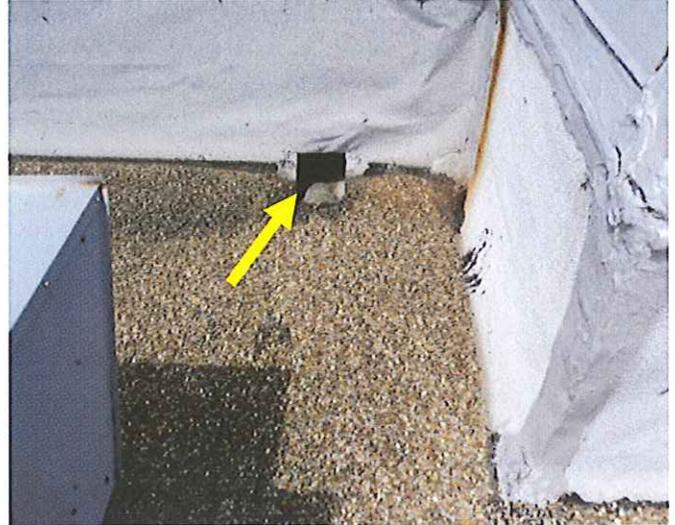
**34-H** This roof drain to scuppers that have no heat cables. This roof could build up a substantial amount of water during the winter months

- c. Roof appears to be in good condition. Some slippage of bitumen which may be affecting the plies
  - d. This roof drains through scuppers and heat cables should be installed to keep them open during the winter months.

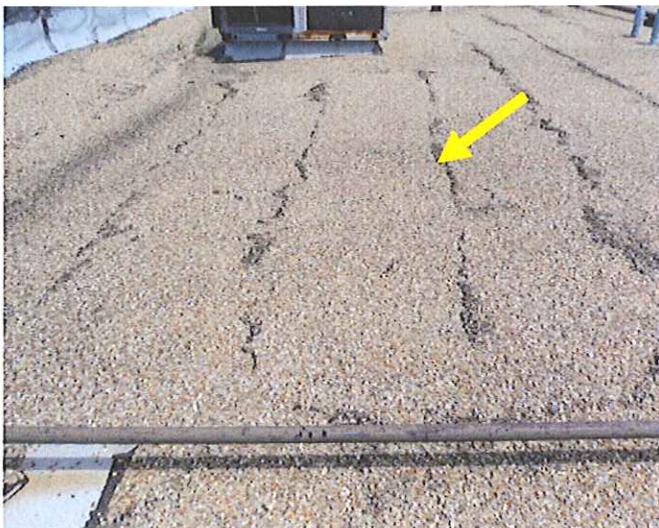
**35-H** Note the top pouring of asphalt is sliding due to improper use of the correct type of asphalt needed for this slope of roof. This is probably affecting the plies as well.
