Willow Creek Restoration Potential Study

May 2015

Lorain County
General Health District

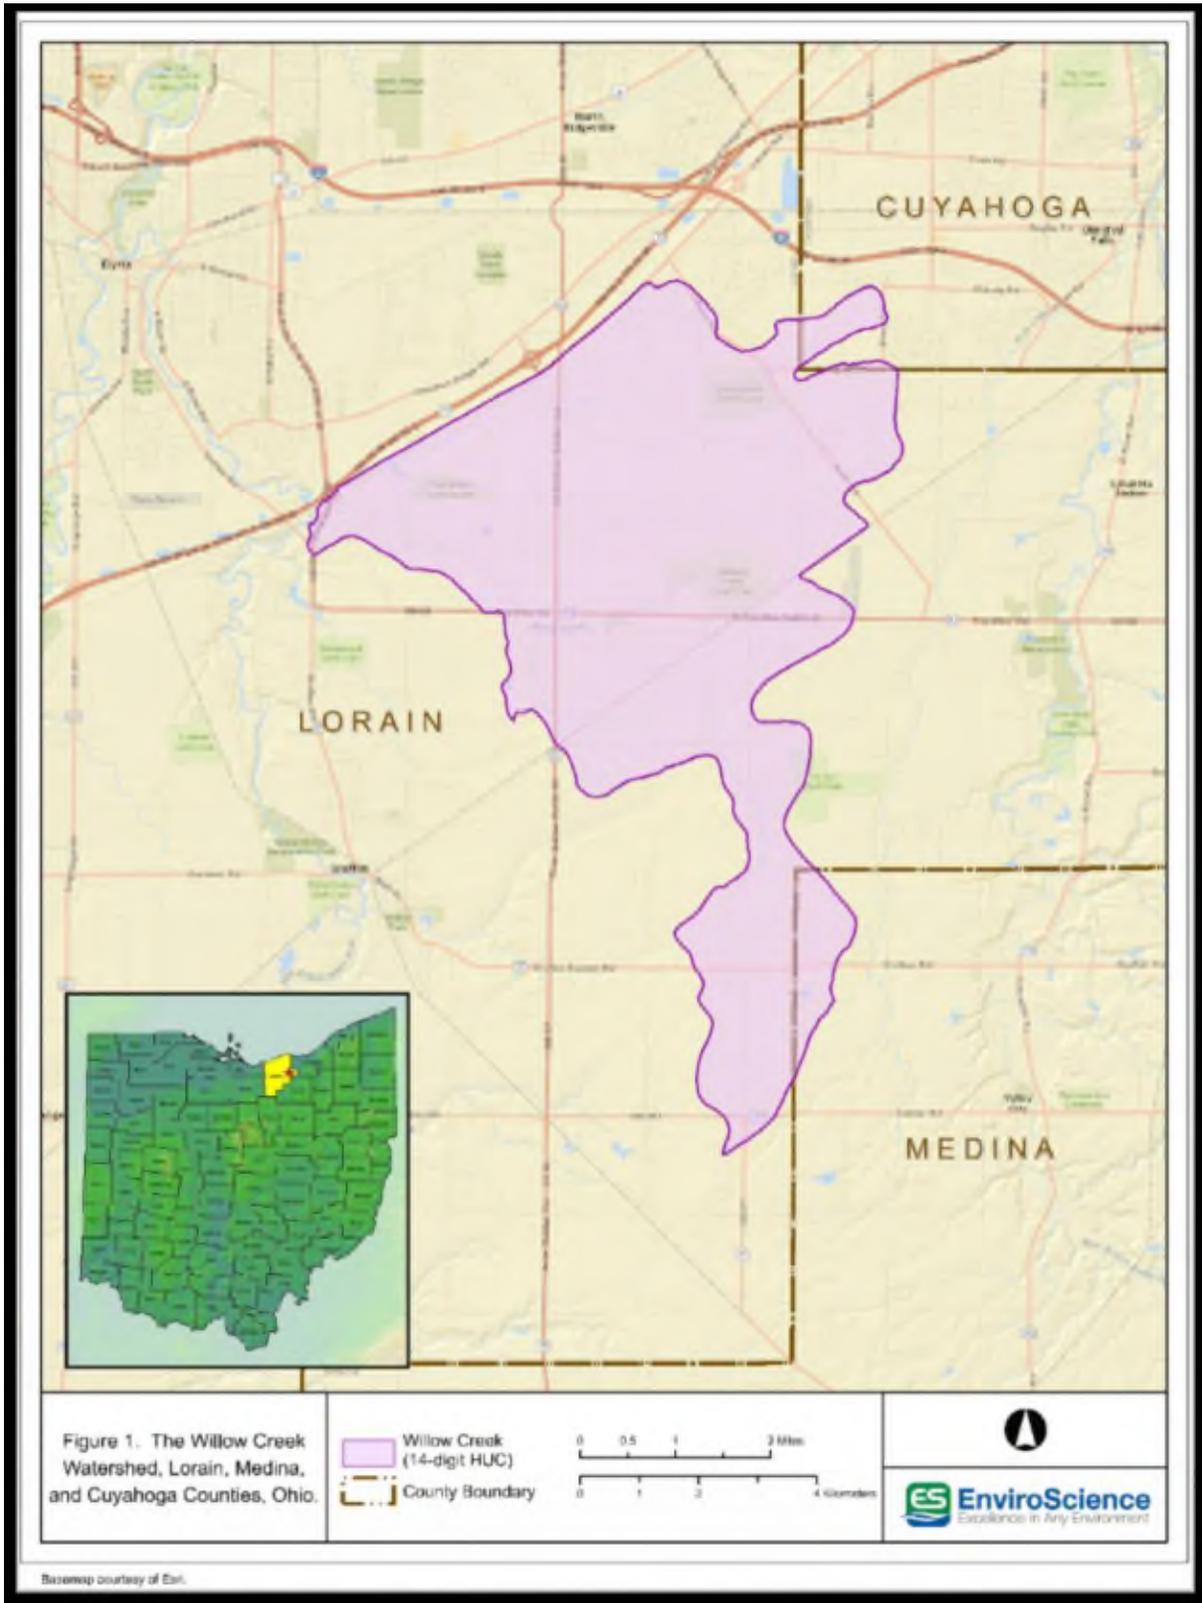
The focus of the study is the Willow Creek watershed. Willow Creek is a tributary to the East Branch of the Black River located mainly within Eaton Township in Lorain County (Figure 1). The Willow Creek watershed drains an area of just over 23 square miles and also includes portions of the City of North Ridgeville, Columbia Township, and Grafton Township in Lorain County, and Olmsted Township in Cuyahoga County.

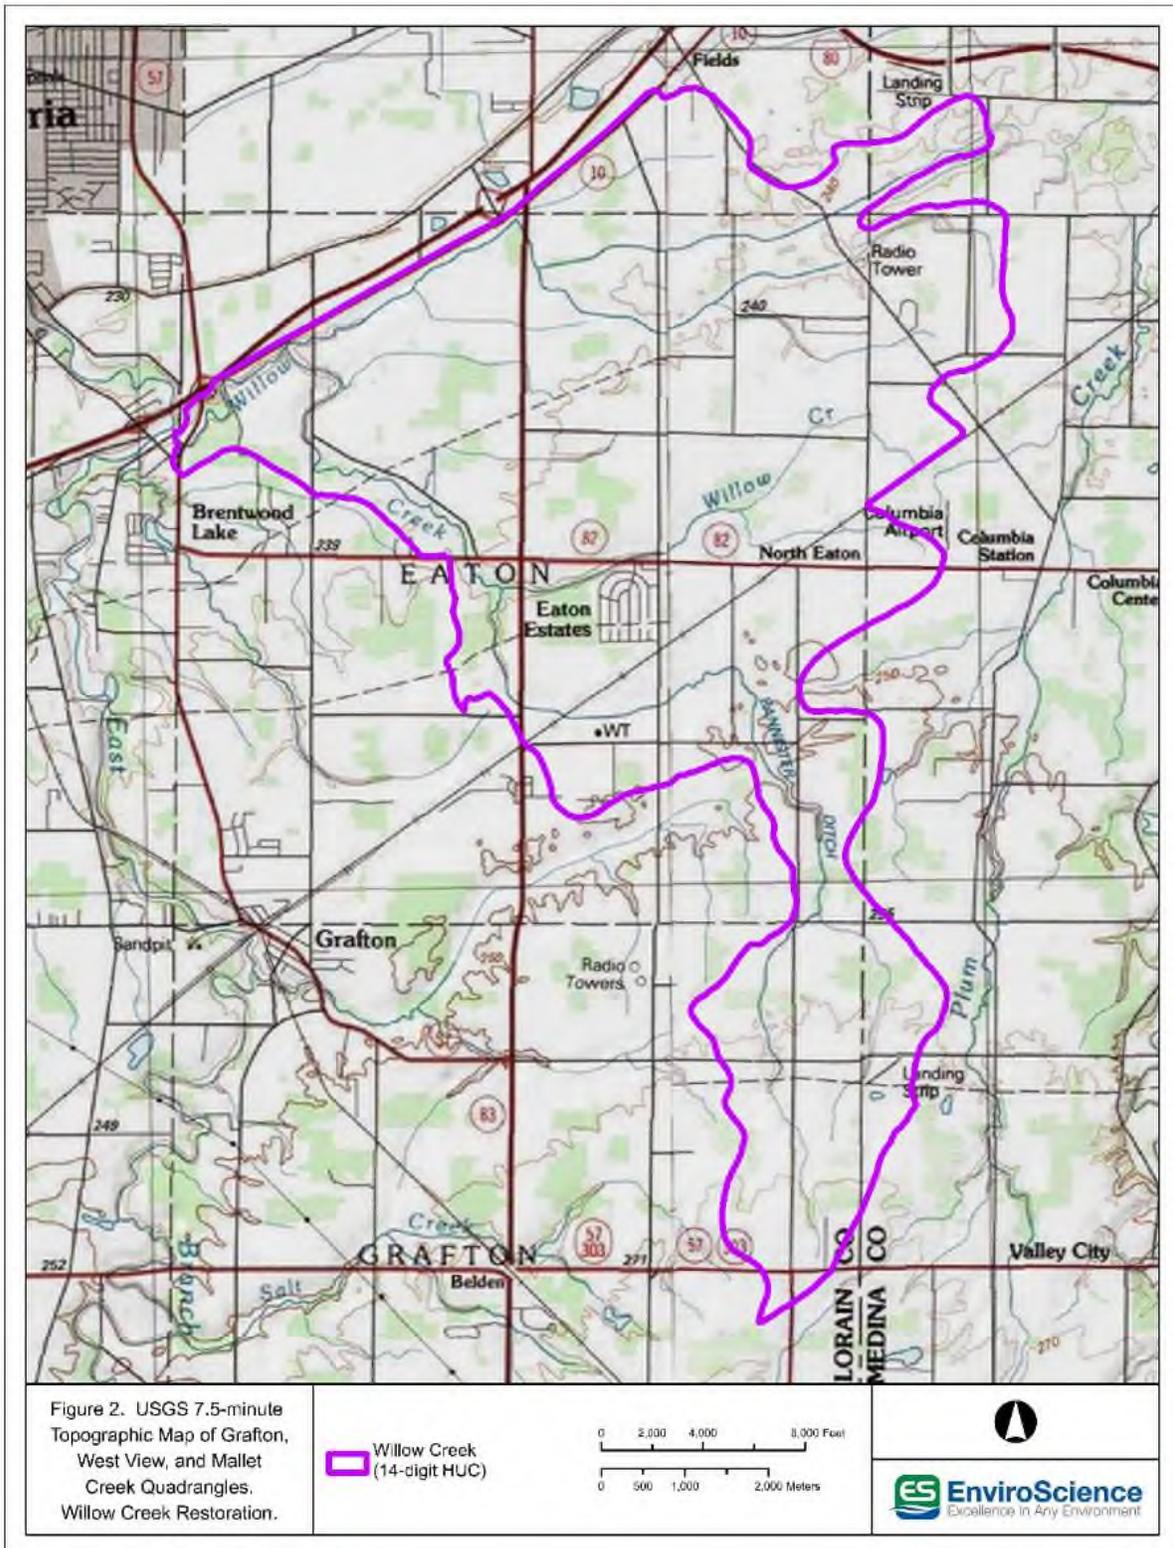
The Willow Creek watershed is characterized by low topographic relief (Figure 2) with poorly drained soils that are often hydric in nature within lower lying areas between the beach ridges. Hydric soils are poorly and very poorly drained soils that formed in low-lying or restricted drainage areas by standing water and/or saturated soils. They tend to be associated with wetlands, but are generally more extensive and can be found in habitat outside of wetland areas. As a result, these soils present severe limitations for on-site home sewage treatment and are a cause of localized flooding. Many hydric soils are seasonally inundated in the early spring and have saturated soils for only a portion of the growing season. This is sufficient for the soils to develop hydric characteristics, such as anaerobic conditions in the upper parts, and support hydrophytic vegetation.

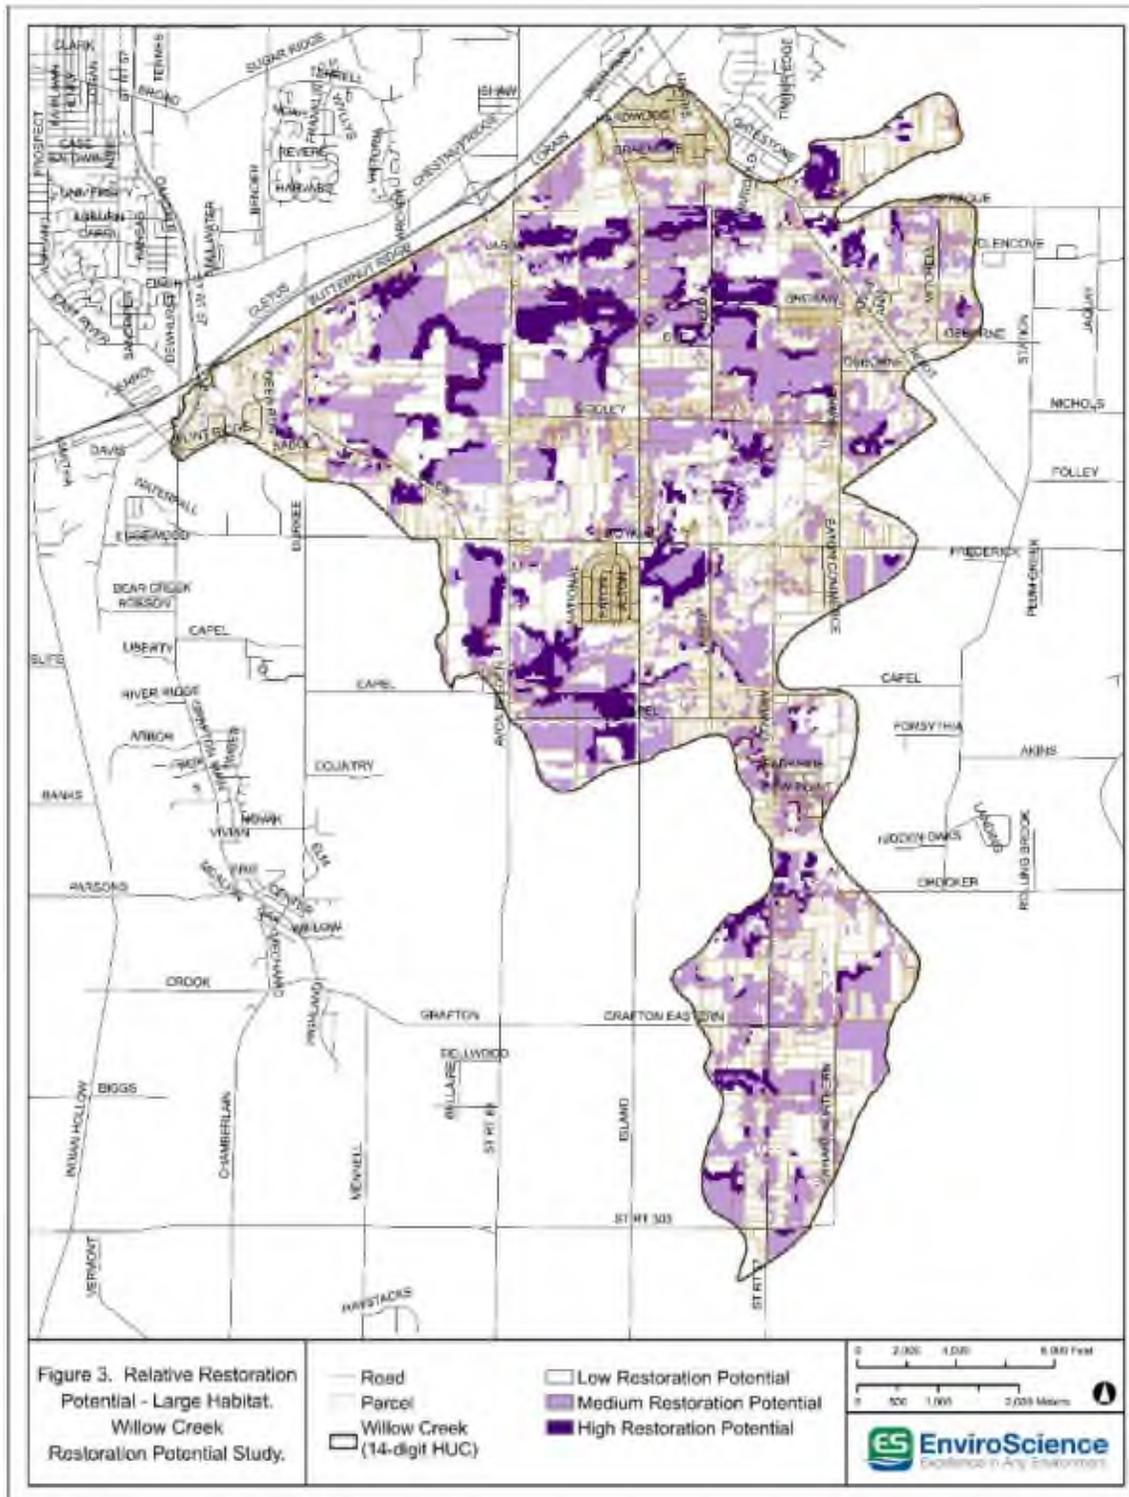
As a result of this model approach, the Willow Creek watershed was assigned restoration potential for habitat and riparian restoration opportunities. Figures 3 and 4 identify the results of the weighted model.

For the Large Habitat Restoration Potential Model, the areas identified as dark-purple represent those areas with greatest potential for restoration based on the attributes identified above. For Riparian Restoration Potential, the areas identified in dark-blue represent those areas of the watershed that have the greatest potential for restoring riparian areas along streams.

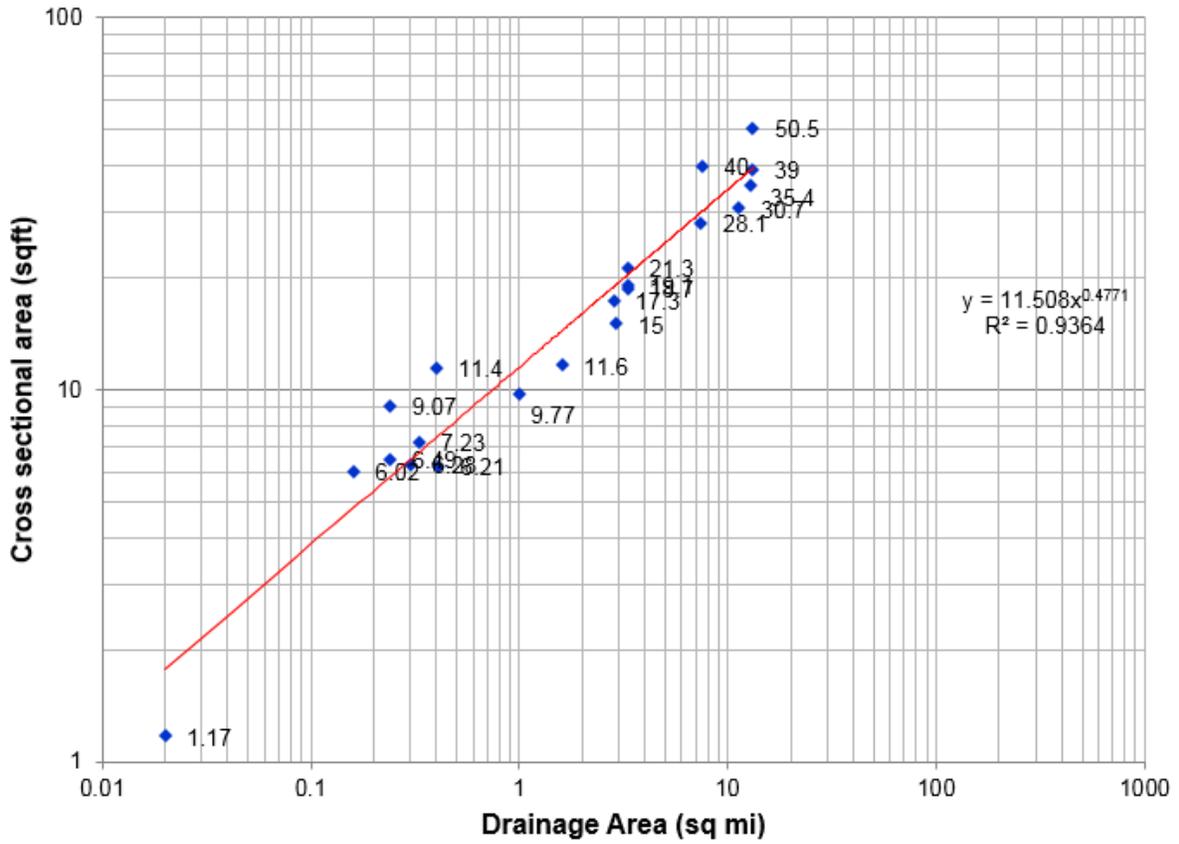
Figure 5. Specific Regional Curve for the Willow Creek Watershed, 2015

A regional curve is a calculated mathematical relationship between a watershed's area and stream hydraulic characteristic such as bankfull width, mean depth, and cross-sectional area. These formulas are often used to calculate the proper dimensions for a stream channel for a watershed of given size. Properly sized stream channels are important for stability in the system, as an improperly sized stream channel can lead to excessive erosion of the stream banks or increased sedimentation problems within the channel. Properly sized stream channels and floodplains are in balance, and transport water and sediment without significant erosion or depositional problems. This in turn improves in-stream habitat and water quality. As more data are collected within the watershed, the regional curve equation can be refined to be improve its accuracy and better predict the proper dimensions. The regional curve that was developed for the Willow Creek watershed in this project is shown in Figure 5.

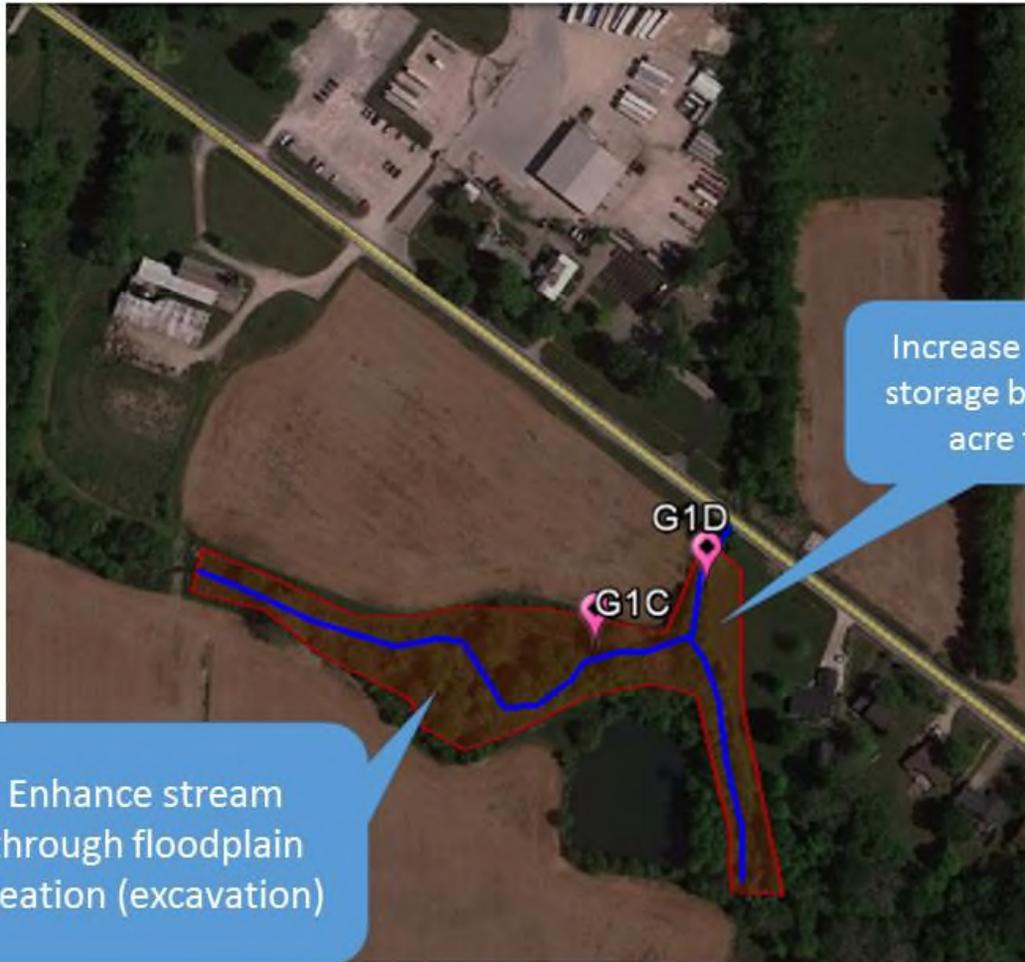
Figure 11 Willow Creek/Lower Dawley Ditch Stream Restoration

Willow Creek Mainstem Floodplain Creation (G1)

Project Rank	Property Owner	Location	Evaluation Sites
5 (64.2 pts)	Moat Properties (Ross), Gladys	South of Giles Rd	G1C, G1D
Approach	Benefits	Project Summary	Options
<ul style="list-style-type: none"> • Floodplain creation (excavation) • Habitat enhancement • Riparian planting 	<ul style="list-style-type: none"> • Improved flood storage • Improved habitat for aquatic life • Nutrient reduction • Pathogen reduction • Reduced suspended sediments 	<ul style="list-style-type: none"> • Restoration of approximately 1,491 l.f. of Willow Creek mainstem and 190 l.f. at the mouth of Dawley Ditch via floodplain creation and channel rehabilitation. • Floodplain created via excavation • Improve habitat quality from a rating of Good to Good/Excellent • Re-establishment of a wooded riparian corridor • Expansion of functional floodplain area by 0.73 acres • Additional flood storage capacity of approximately 1.38 acre ft. 	No additional options evaluated

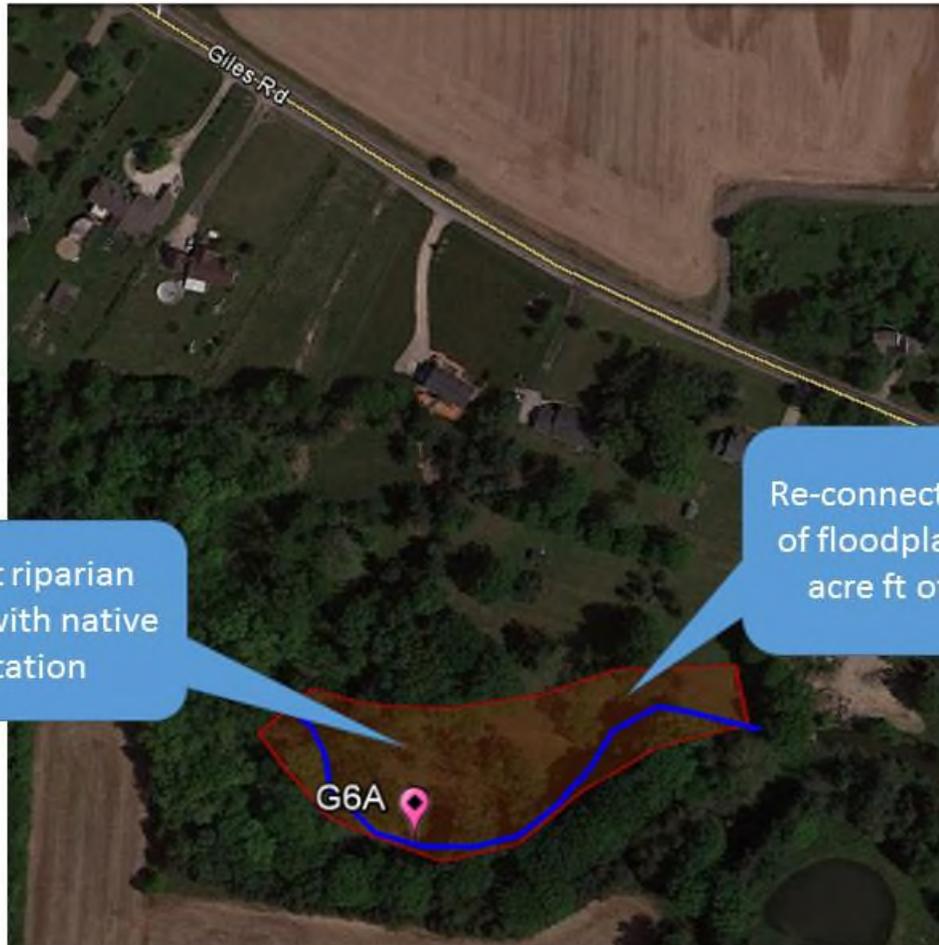
Figure 13. Willow Creek Mainstem Bank Stabilization

Willow Creek Floodplain Enhancement (Moat Properties G6)

Re-plant riparian corridor with native vegetation

Re-connect 0.33 acres of floodplain for 0.42 acre ft of storage

Project Rank	Property Owner	Location	Evaluation Sites
9 (55.8 pts)	Moat Properties (Ross)	South of Giles Rd	G6A
Approach	Benefits	Project Summary	Options
<ul style="list-style-type: none"> • Floodplain creation (excavation) • Habitat enhancement • Riparian planting 	<ul style="list-style-type: none"> • Improved flood storage • Improved habitat for aquatic life • Nutrient reduction • Pathogen reduction • Reduced suspended sediments 	<ul style="list-style-type: none"> • Restoration of approximately 660 l.f. of the mainstem of Willow Creek via re-connection to floodplain and riparian planting. • Floodplain re-connected via excavation • Improve stream habitat quality from a rating of Good to Excellent • Re-establishment of a wooded riparian corridor • Expansion of functional floodplain area by 0.33 acres • Additional flood storage capacity of approximately 0.42 acre ft. 	No additional options evaluated

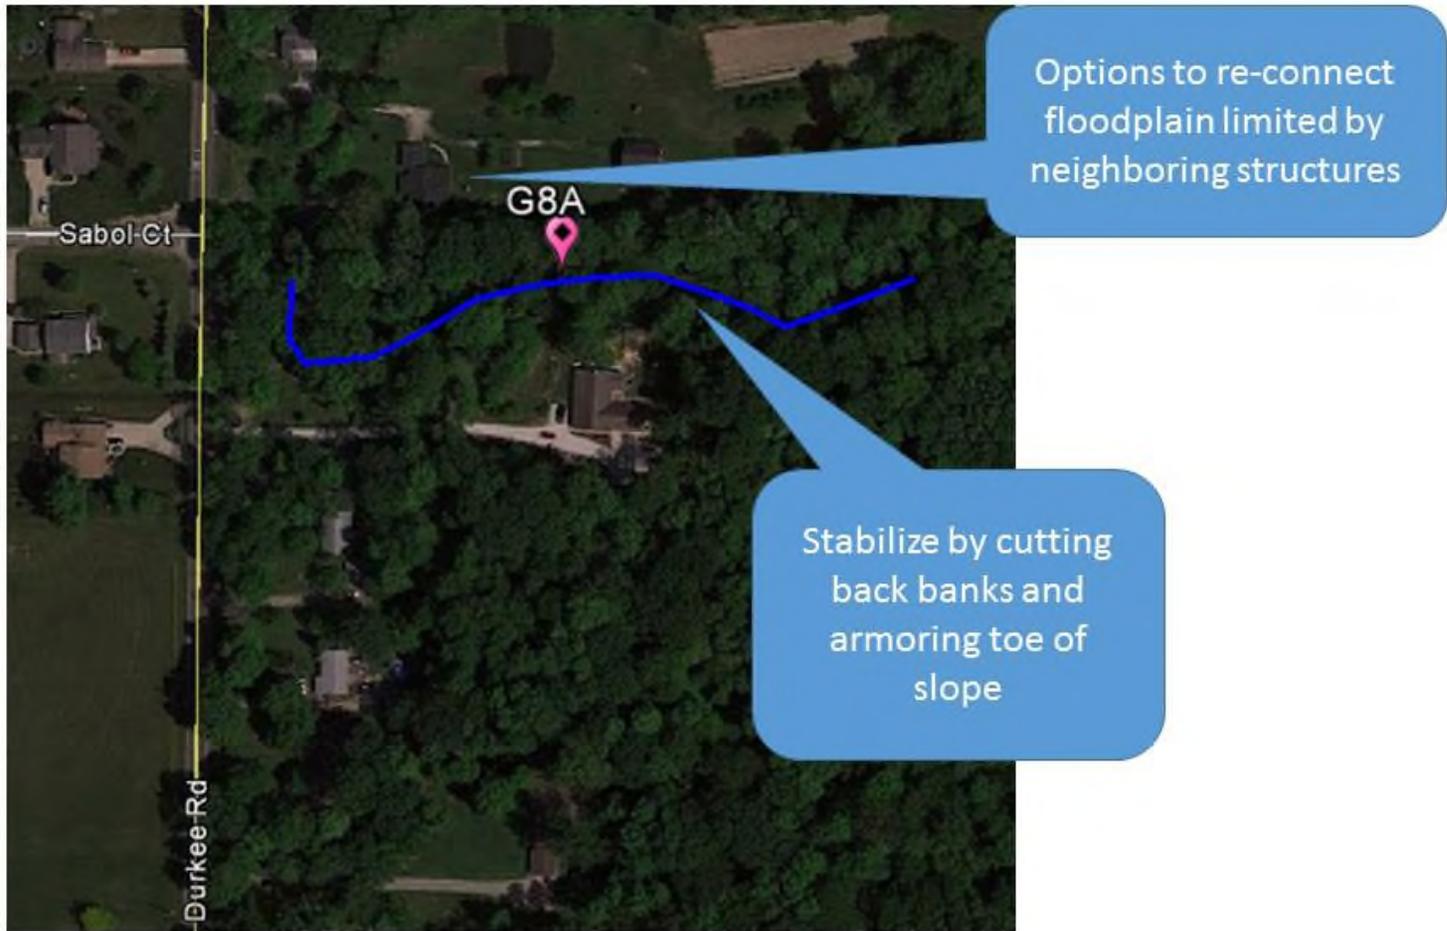
Figure 14. Willow Creek Mainstem Bank Stabilization

Willow Creek Mainstem Bank Stabilization (G8)

Project Rank	Property Owner	Location	Evaluation Sites
10 (35.4 pts)	Galvin	South of Giles Rd	G6A
Approach	Benefits	Project Summary	Options
<ul style="list-style-type: none"> • Stabilization of eroding banks • Habitat enhancement • Riparian planting 	<ul style="list-style-type: none"> • Decreased erosion and tree loss • Decreased loads of suspended sediments 	<ul style="list-style-type: none"> • Stabilization of approximately 1,000 l.f. of stream bank along the mainstem of Willow Creek via slope stabilization and bank armoring • Minimal floodplain re-connected (limited by surrounding land use) • Minimal improvement in habitat quality or flood storage 	No additional options evaluated

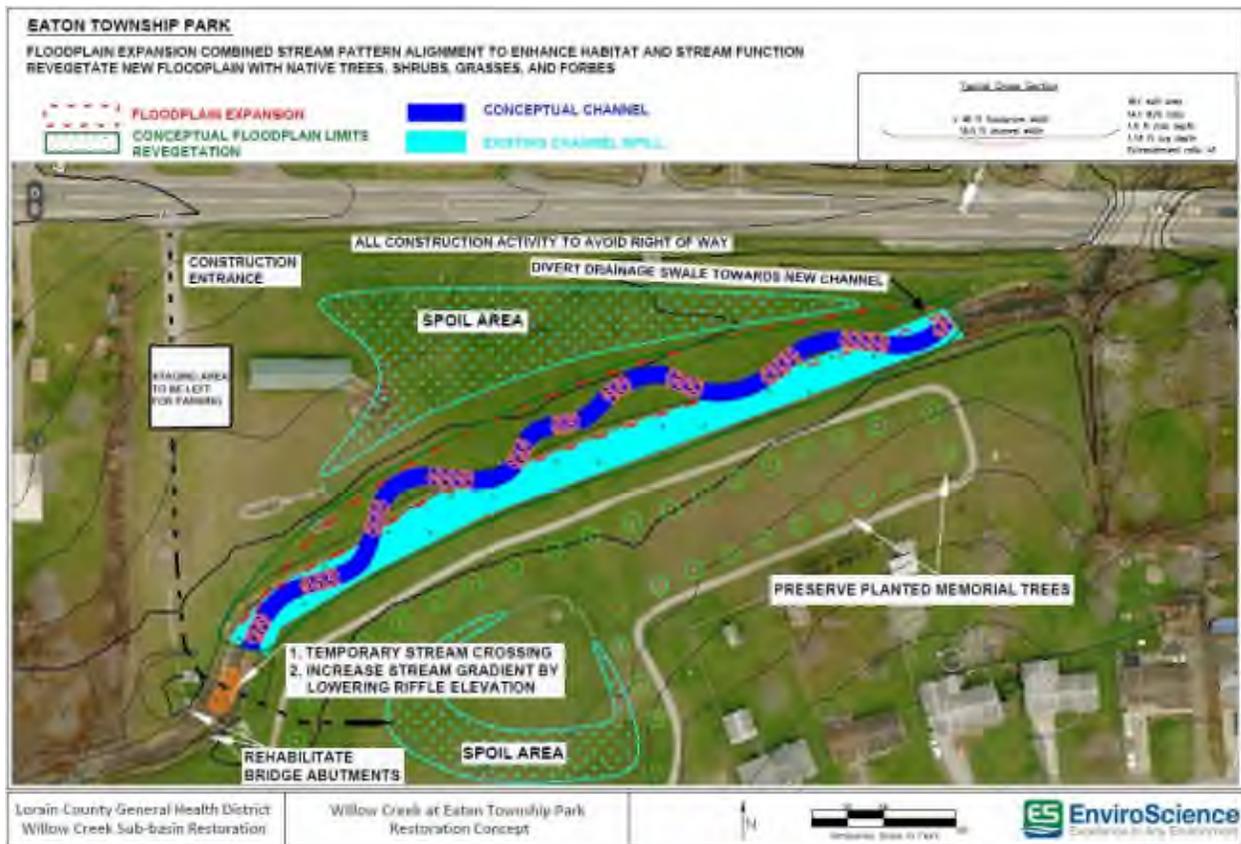
Figure 17. Willow Creek Restoration Concept - Eaton Township Park

This conceptual restoration plan includes stream and floodplain restoration of Willow Creek at the Eaton Township Park, located south of Royalton Road (SR 82) between Wooster Avon Lake Road (SR 83) and Island Road (SR 58). The center of the project is located at approximately 41.313456° N, 82.008750° W. At this location, the existing channel of Willow Creek has been channelized and is detached from its floodplain. The riparian corridor is open, with no tree cover. The goal of the restoration is to improve the habitat within this reach of Willow Creek by adding a more natural pattern to the stream, increase habitat diversity by adding riffles and pools, and excavating a floodplain to allow for storage of flood flows. Native plants will be installed in floodplain and wetland areas.

The addition of sinuosity to the stream will increase the stream length by 100-200 feet in this reach. Improvements to the instream habitat should raise the habitat quality from very poor to good. The construction of floodplains will increase flood storage capacity by 0.9-1.0 ac-ft. In addition, the approximately 0.7 acres of floodplain wetlands will improve sediment retention and nutrient processing, helping to improve water quality within Willow Creek. In addition to the ecological improvements, the township's existing park will be improved, and important elements will be preserved. The parking area for the picnic shelter will be used as a construction staging area, and will be left as an improved parking area for future township use. Spoil areas will be low (<2 ft) to not obstruct views, and will be placed in upland lawn areas within the park. One option for a spoil area is to be placed around the ball field to improve spectators' views of the field. The bridge abutments near the temporary stream crossing will be rehabilitated. The existing trail and memorial trees will be preserved.

Because of its location and high visibility from the road and the park, this restoration project provides a significant opportunity for public education. Motorists will see the project from SR 82, and park visitors will have a chance to see the project and view educational signs about the benefits of ecological restoration. As such, it is hoped that this project will serve as a demonstration project that will lead to greater local support for future restoration projects within the Willow Creek watershed.

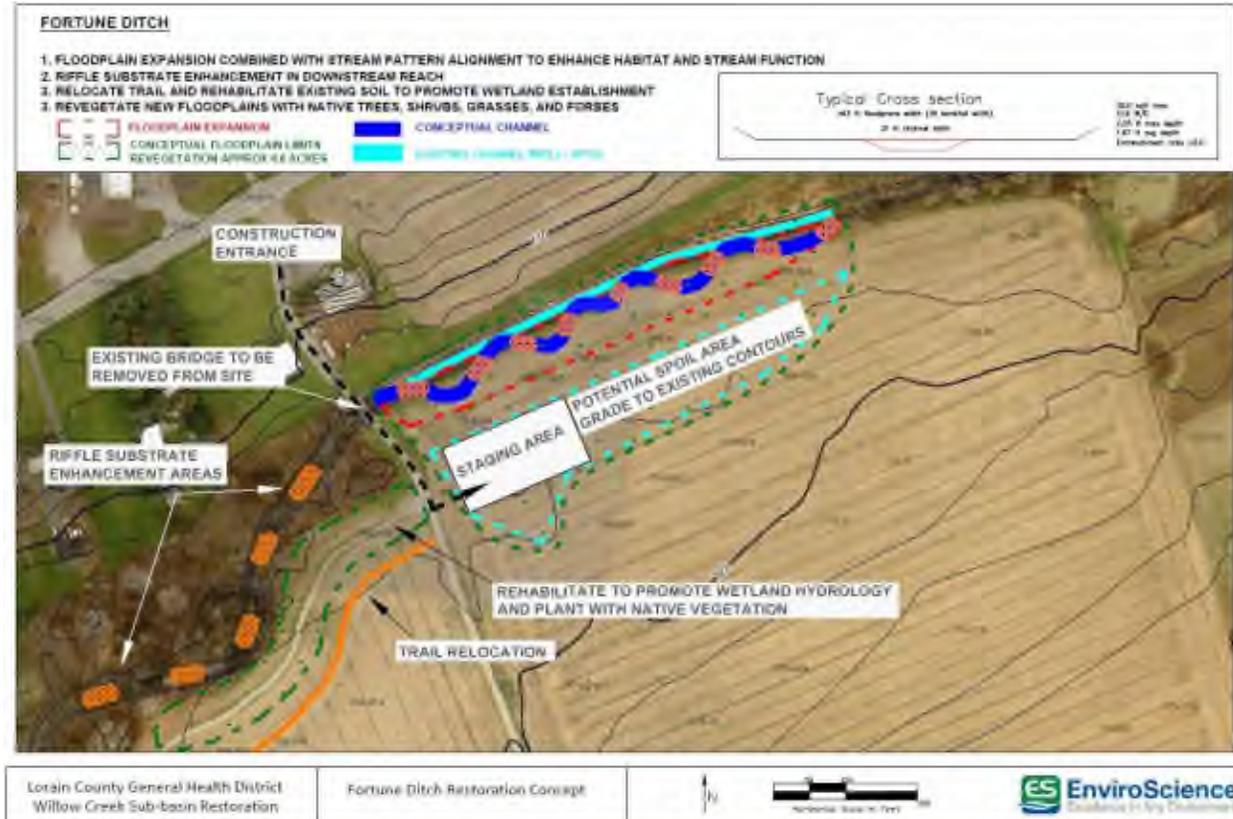
Figure 18. Fortune Ditch Restoration Concept

This conceptual restoration plan includes stream and floodplain restoration of Fortune Ditch within the 98-acre Margaret Peak Nature Preserve, owned by Eaton Township. The site is located south of Butternut Ridge Road between Wooster Avon Lake Road (SR 83) and Archer Road. The center of the project is located at approximately 41.345816° N, 82.033067°. At this location, the existing channel of Fortune Ditch has been channelized and is detached from its floodplain. The riparian corridor is open, with no tree cover. The goal of the restoration is to improve the habitat within this reach of Fortune Ditch by adding a more natural pattern to the stream, increase habitat diversity by adding riffles and pools, and excavating a floodplain to allow for storage of flood flows. Native plants will be installed in floodplain and wetland areas.

The addition of sinuosity to the stream will increase the stream length by approximately 100-200 feet in this reach. The construction of approximately 4.5-5 acres of floodplain wetlands will increase flood storage capacity by 2.1-2.2 ac-ft. In addition, the wetlands will improve sediment retention and nutrient processing, helping to improve water quality within Fortune Ditch. Soil from the floodplain excavation will be placed to the south of the floodplain, tying into an existing beach ridge. An existing unused bridge near the active culvert crossing will be removed.

Because of its location and high visibility from Butternut Ridge Road, this restoration project provides a significant opportunity for public education. Motorists will see the project from the road, and park visitors will have a chance to see the project and view educational signs about the benefits of ecological restoration. This will also add another point of interest near the beginning of the walking trail. As such, it is hoped that this project will serve as a demonstration project that will lead to greater local support for future restoration projects within the Willow Creek watershed.

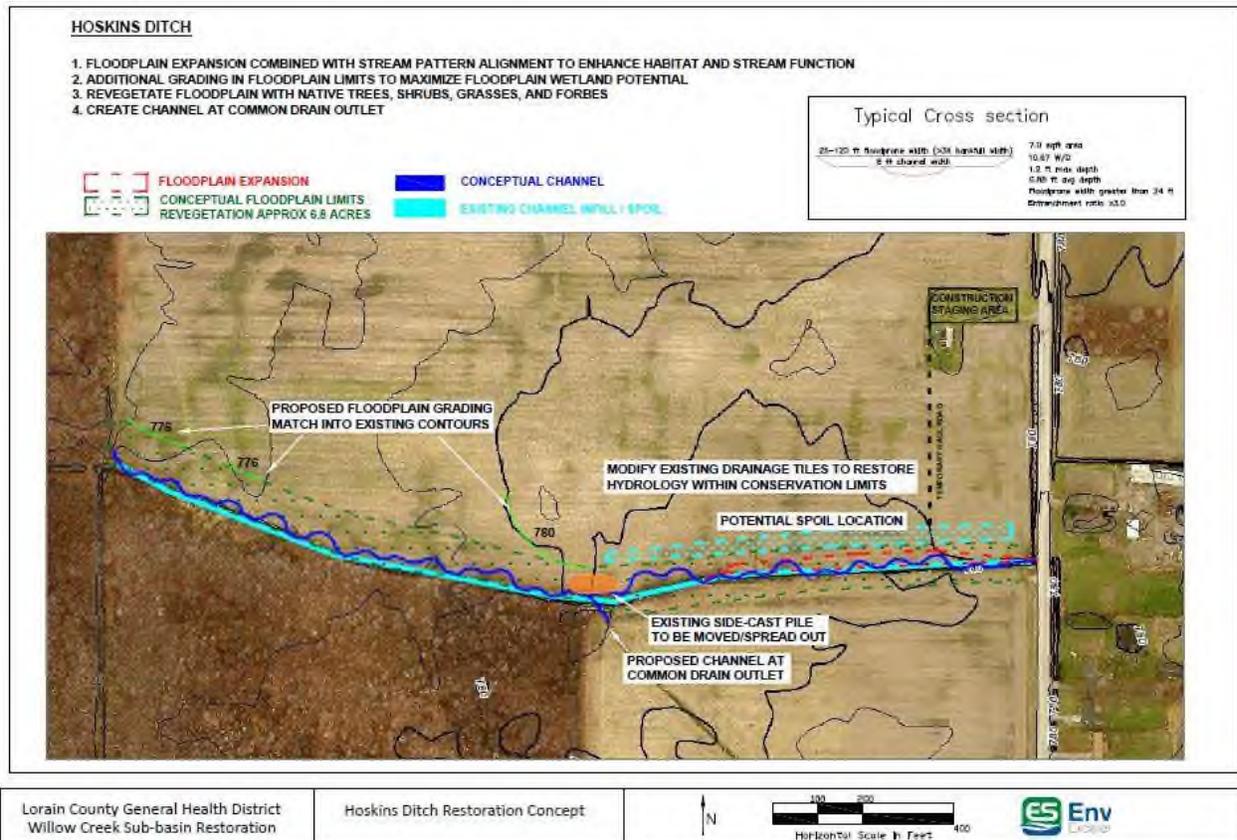
Figure 19, Hoskins Ditch Restoration Concept

This conceptual restoration plan includes stream and floodplain restoration of Hoskins Ditch on private property owned by Ross Environmental Services, Inc. The site is located west of Wooster Avon Lake Road (SR 83) and north of Cooley Road (CR 141). The center of the project is located at approximately 41.335266° N, 82.024772° W. At this location, the existing channel of Fortune Ditch has been channelized. To the east, the riparian corridor is open, with no tree cover. The western side of the parcel contains Category 3 (high quality) forested wetlands. The goal of the restoration is to improve the habitat within this reach of Hoskins Ditch by adding a more natural pattern to the stream, increase habitat diversity by adding riffles and pools, and excavating a floodplain to allow for storage of flood flows. Flood connections will be reestablished between Hoskins Ditch and the forested wetlands, to increase the flow of water into the wetlands and increase their functionality. Native plants will be installed in floodplain and wetland areas.

The addition of sinuosity to the stream will increase the stream length by approximately 300-400 feet in this reach. The construction of approximately 2.0-2.5 acres of floodplain wetlands will increase flood storage capacity by 1.5-2.0 ac-ft. In addition, the wetlands will improve sediment retention and nutrient processing, helping to improve water quality within Hoskins Ditch. Soil

from the floodplain excavation will be placed to the north of the floodplain to provide additional protection for the adjacent agricultural areas.

Because of its location, this restoration provides limited opportunities for public education. If walking trails from the nearby Margaret Peak Nature Preserve were extended, public education opportunities would be increased.
